Mitigation of Active Corrosion Fatigue and Corrosion Pit Initiated Fatigue in AA7075-T6 with Low Plasticity Burnishing

Paul S. Prev y and N. Jayaraman
Lambda Research

John T. Cammett
NAVAIR

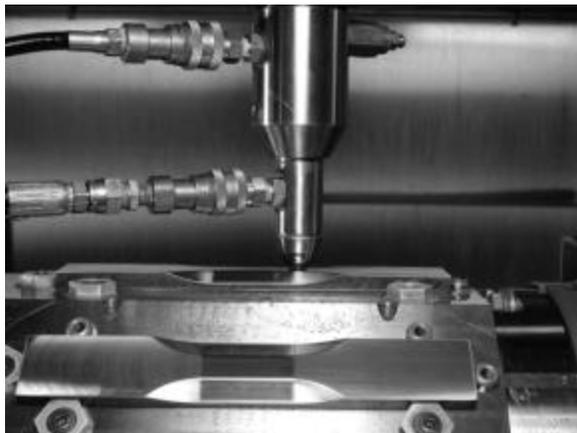
Figure 1 – LPB processing of fatigue samples with a single point contact LPB tool in a 4-axis CNC mill.

Using CNC positioning, the tool path is controlled so that the surface is covered with a series of passes at a separation maintained to achieve maximum compression with minimum cold working. The tool may be moved in any direction along the surface of a complex work piece, as in a typical multi-axis CNC machining operation. The LPB processing of fatigue specimens used in this investigation is depicted in Figure 1.

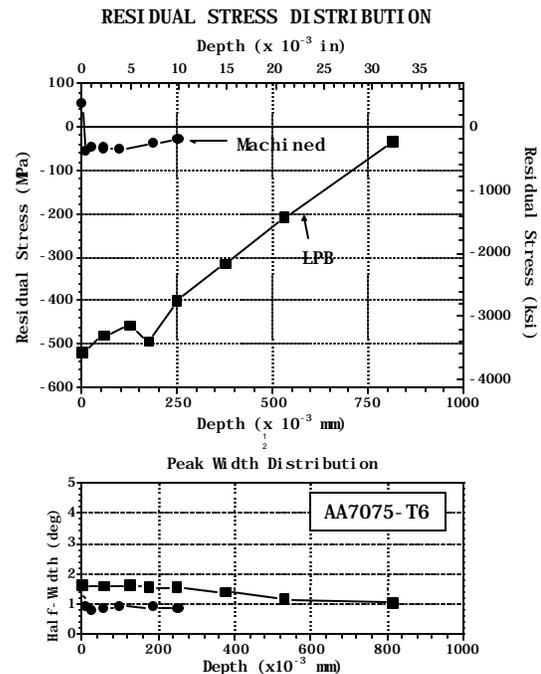
Figure 2 - Residual stress and half width distribution in machined and LPB processed AA7075-T6.

The residual stress distributions developed by machining and LPB processing of 7075-T6 are shown in Figure 2. Machining of 7075-T6 produced low tension on the surface and compression of less than -68 MPa (-10 ksi) below the surface. In contrast, LPB produced maximum compression on the order of -480 MPa (-70 ksi) between the surface and a depth of nominally 0.2 mm (0.008 in.). Maximum cold work occurs from the surface through the region of maximum compression, and then diminishes with depth. X-ray diffraction measurement could not be made reliably below a depth of 0.5 mm (0.02 in.) in the 7075-T6 because of the coarse grain size encountered at depths beneath the deformed surface layer.

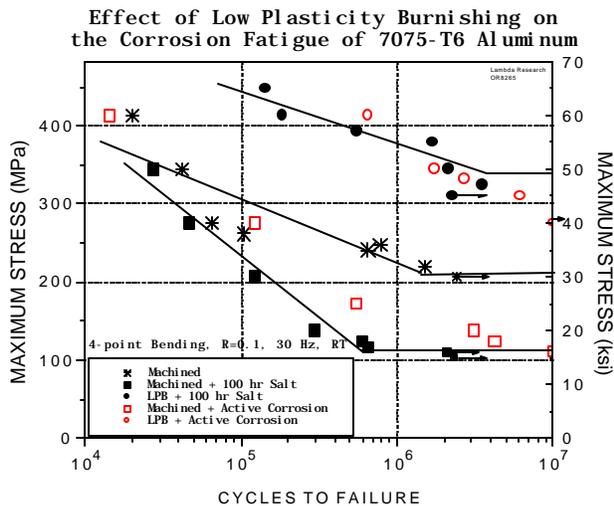
Figure 3 - High cycle fatigue results for salt fog pitted and active corrosion fatigue of machined 7075-T6 with and without LPB processing prior to exposure to corrosion.

The S/N curves generated for 7075-T6 in both the baseline (as-machined) and LPB conditions, after 100 hr salt fog exposure or active corrosion fatigue, are presented in Figure 3. Fatigue tests were continued for a minimum of 2.5 x 10⁶ cycles with a maximum run-out at 1.2 x 10⁷ cycles. The fatigue data are presented as semi-logarithmic S/N curves in terms of the maximum stress.

The S/N curves for samples with pitting from prior salt fog exposure appeared to exhibit an endurance limit, implying infinite life below some threshold stress level. As commonly observed in studies of corrosion fatigue, the S/N curves for samples exposed to active corrosion during fatigue testing do not appear to have an endurance limit.¹⁴ In the discussion that follows, the results are considered and compared in terms of the fatigue life at nominally 2 x 10⁶ cycles.

The machined (end milled) surface condition produced an apparent endurance limit on the order of 200 MPa (30 ksi). Salt fog exposure for 100 hrs reduced the endurance limit to nominally 100 MPa

(15 ksi), half that of the original machined surface before exposure to salt fog generated pitting corrosion. Loss of nominally half the extended life fatigue strength following salt fog corrosion pitting appears to be typical of the degradation reported in the literature³. The fractional loss of fatigue life at stress levels above the endurance limit increased rapidly as the maximum stress level reduced, reaching an order of magnitude at the 200MPa (30ksi) endurance limit

Active corrosion fatigue in 3.5% NaCl solution, with no prior corrosion damage, degraded the fatigue strength relative to the as-machined condition by an amount only slightly less than prior pitting corrosion up to a life of 10⁷ cycles. Note the failure occurring in active corrosion fatigue at the 10⁷ cycle endurance limit for a maximum stress of 110 MPa (16 ksi). The data appear to suggest further reduction in fatigue strength with increasing life and the absence of an endurance limit for active corrosion fatigue of the machined 7075-T6 surface.

LPB prior to salt fog pitting resulted in a 70% increase in the endurance limit, from nominally 200 MPa (30 ksi) to over 330 MPa (48 ksi). LPB prior to corrosion pitting increased the fatigue life at stress levels above the base line endurance limit by two orders of magnitude, a 100X life increase over the un-corroded original machined surface.

A comparable benefit in fatigue performance was observed for LPB prior to active corrosion fatigue in 3.5% NaCl solution. As noted above, a true endurance limit may not exist for the active corrosion fatigue mechanism; however, the fatigue strength at 10⁷ cycles was at least 282MPa (41ksi), 32% higher than the un-corroded original machined surface. Fatigue lives were 100 times that of the baseline for stress levels above the baseline endurance limit of 220 MPa (32 ksi).

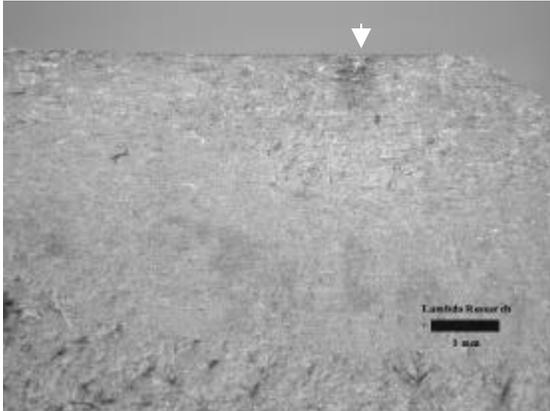
Figure 4 – Typical surface fatigue initiation site on machined 7075-T6 in active corrosion fatigue.

Fractographic analysis revealed that all the fatigue failures in specimens without prior LPB, whether exposed to salt fog pitting or active corrosion fatigue, initiated at the surface. A typical surface fatigue initiation site is shown in Figure 4. All of the salt fog pitted sample initiations were exclusively from corrosion pits, as observed previously⁶. Specimens tested at lower stresses generally exhibited origins from a single pit or surface location, while specimens tested at higher stress levels tended to have multiple nucleation sites.
