Restoring Fatigue Performance Of Corrosion Damaged Aa7075-T6 and Fretting in 4340 Steel with Low Plasticity Burnishing

Paul S. Prevéy
Lambda Research

John T. Cammett
NAVAIR

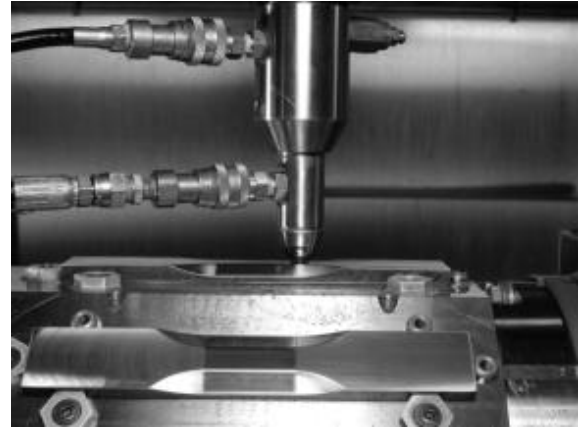
Figure 1 – LPB processing of fatigue samples with a single point contact LPB tool in a 4-axis CNC mill.

Using CNC positioning, the tool path is controlled so that the surface is covered with a series of passes at a separation maintained to achieve maximum compression with minimum cold working. The tool may be moved in any direction along the surface of a complex work piece, as in a typical multi-axis CNC machining operation. The LPB processing of fatigue

specimens used in this investigation is depicted in Figure 1.

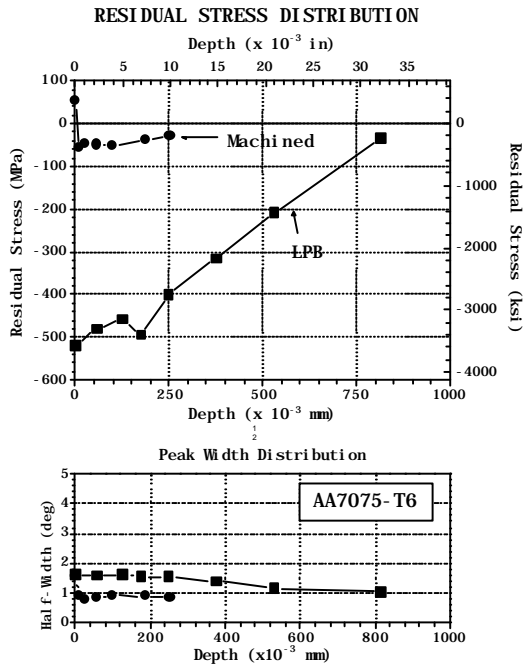
Figure 2 - Residual stress and half width distribution in machined and LPB processed AA7075-T6.

The residual stress distributions developed by machining and LPB processing of 7075-T6 are shown in Figure 2. Machining of 7075-T6 produced low tension on the surface and compression of less than -68 MPa (-10 ksi) below the surface. In contrast, LPB produced maximum compression on the order of -480 MPa (-70 ksi) between the surface and a depth of nominally 0.2 mm (0.008 in.). Maximum cold work occurs from the surface through the region of maximum compression, and then diminishes with depth. X-ray diffraction measurement could not be made reliably below a depth of 0.5 mm (0.02 in.) in the 7075-T6 because of the coarse grain size encountered at depths beneath the deformed surface layer.

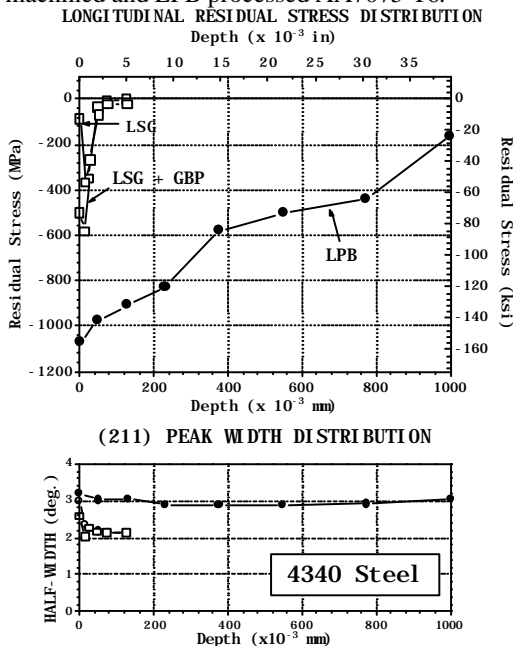
Figure 3 - Residual stress and diffraction peak half-width distributions of low stress ground (LSG), glass bead peened (GBP) and low plasticity burnished (LPB) 4340 steel.

Residual stress and cold work distributions produced by grinding and LPB of 4340 steel are shown in Figure 3. Low stress grinding alone left the surface slightly compressive, with a subsurface peak compression on nominally -350 MPa (-50.8 ksi). Grinding and glass bead peening (GBP) of 4340 steel produced surface compression on the order of -500 MPa (-72.6 ksi) and a compressive layer not exceeding a depth of 75 μ m (0.003 in.). LPB produced a compressive layer with a maximum of nominally -100 MPa (-14.5 ksi) at the surface and extending over 1 mm (0.04 in.) into the surface.

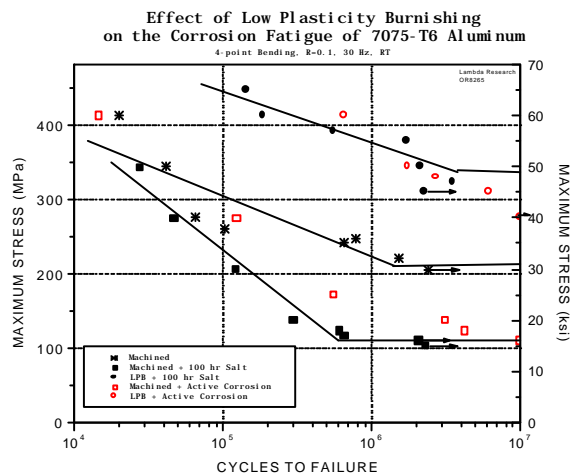
Figure 4 - High cycle fatigue results for salt fog pitted and active corrosion fatigue of machined 7075-T6 with and without LPB processing prior to exposure to corrosion.

The S/N curves generated for 7075-T6 in both the baseline (as-machined) and LPB conditions, after 100 hr salt fog exposure or active corrosion fatigue, are presented in Figure 4. Fatigue tests were continued for a minimum of 2.5×10^6 cycles with a maximum run-out at 1.2×10^7 cycles. The fatigue data are presented as semi-logarithmic S/N curves in terms of the maximum stress.

The S/N curves for samples with pitting from prior salt fog exposure appeared to exhibit an endurance limit, implying infinite life below some threshold stress level. The S/N curves for samples exposed to active corrosion fatigue during testing do not appear to have an endurance limit, as is commonly observed in studies of corrosion fatigue.¹⁶ In the discussion that follows, the results are considered and compared in terms of the fatigue life at nominally 2×10^6 cycles.

The machined (end milled) surface condition produced an apparent endurance limit on the order of 200 MPa (30 ksi). Salt fog exposure for 100 hrs reduced the endurance limit to nominally 100 MPa (15 ksi), half that of the original machined surface

before exposure to salt fog generated pitting corrosion. Loss of nominally half the extended life fatigue strength following salt fog corrosion pitting appears to be typical of the degradation reported in the literature³. The fractional loss of fatigue life at stress levels above the endurance limit increased rapidly as the maximum stress level reduced, reaching an order of magnitude at the 200MPa (30ksi) endurance limit

Active corrosion fatigue in 3.5% NaCl solution, with no prior corrosion damage, degraded the fatigue strength relative to the as-machined condition by an amount only slightly less than prior pitting corrosion up to a life of 10^7 cycles. A failure occurred in active corrosion fatigue at the nominal 100 MPa (14.5 ksi) endurance limit for pitting corrosion. The data appear to suggest further reduction in fatigue strength with increasing life and the absence of an endurance limit for active corrosion fatigue of the machined 7075-T6 surface.

LPB prior to salt fog pitting resulted in a 70% increase in the endurance limit, from nominally 200 MPa (30 ksi) to over 330 MPa (48 ksi). LPB prior to corrosion increased the fatigue life at stress levels above the endurance limit 310 MPa (45 ksi) by two orders of magnitude, or one hundred times that of the baseline machined surface.

A comparable benefit in fatigue performance was observed for LPB prior to active corrosion fatigue in 3.5% NaCl solution. As noted earlier, a true endurance limit may not exist for the active corrosion fatigue mechanism; however, the fatigue strength at 10^7 cycles was at least 282MPa (41ksi). Fatigue lives were 100 times that of the baseline for stress levels above 275 MPa (40 ksi).

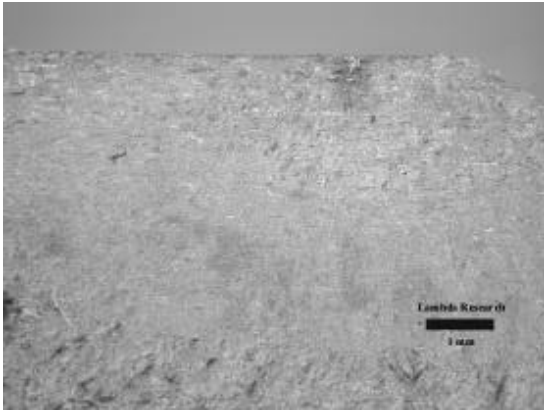
Figure 5 – Typical surface fatigue initiation site on machined 7075-T6 in active corrosion fatigue.

Fractographic analysis revealed that all of the fatigue failures in specimens without prior LPB, whether exposed to salt fog pitting or active corrosion fatigue, initiated at the surface. A typical surface fatigue initiation site is shown in Figure 5. All of the salt fog pitted sample initiations were exclusively from corrosion pits, as observed previously⁶. Specimens tested at lower stresses generally exhibited origins from a single pit or surface location, while specimens tested at higher stress levels tended to have multiple nucleation sites.

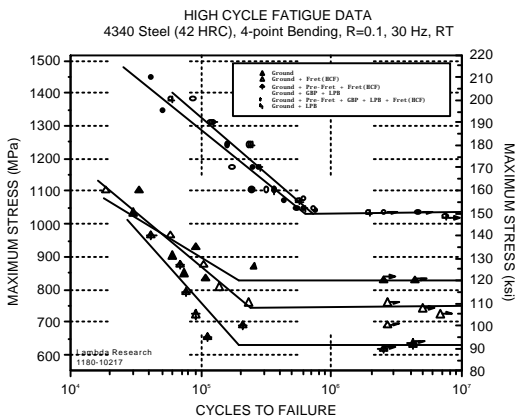
Figure 6 – 4340 steel fretting fatigue results, as ground and with prior LPB treatment. Multiple fretting exposures simulate service damage, overhaul, and return to service.

The fretting fatigue results for 4340 steel are shown in Figure 6. The ground baseline samples produced an endurance limit of 827 MPa (120.0 ksi). Fretting of as-ground samples during fatigue testing reduced the endurance limit to nominally 758 MPa (110.0 ksi).

Pre-fretting followed by fretting during fatigue testing (simulating returning a fretted part to continued service) reduced the HCF endurance limit further to nominally 620 MPa (90.0 ksi), a loss of 25% of the initial fatigue strength.

LPB, either before or after fretting, produced an endurance limit of nominally 1033 MPa (150.0 ksi), 25% higher than ground 4340 without fretting damage. Even with fretting both before and after LPB, intended to simulate application of LPB of a component during overhaul followed by return to service, LPB gave the same 25% endurance limit increase, indicating complete mitigation of the fretting fatigue debit.

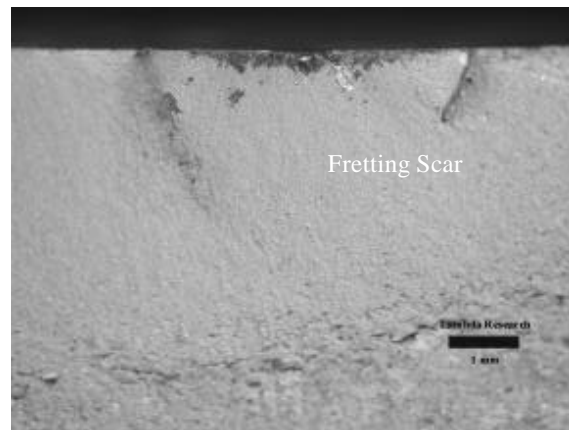
Figure 7 – Fracture face of a 4340 steel fretting fatigue sample showing initiation from the edge of the fretting scar.

Fatigue initiated from the edge of the fretting scar in all of the 4340 samples without LPB. A typical fracture face, with the fretting scar visible at the top, is shown in Figure 7. Fatigue initiated in all of the LPB samples subsurface, just below the compressive layer, indicating a fatigue strength higher than indicated by the results. The subsurface failures are interpreted as a limitation of the test technique and sample design which combined to allow the maximum tension to occur below the highly compressive test surface.
