THE USE OF ENGINEERED COMPRESSIVE RESIDUAL STRESSES TO MITIGATE STRESS CORROSION CRACKING AND FATIGUE FAILURE IN 300M LANDING GEAR STEEL

ABSTRACT

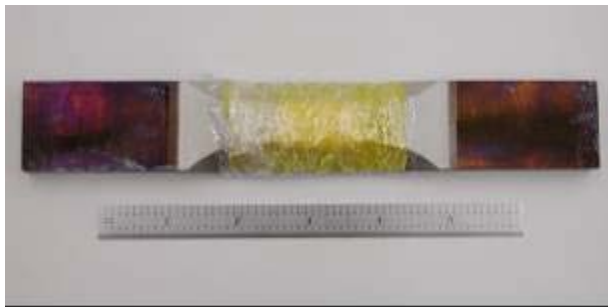
FIGURE 3 - A thick section specimen with 3.5% salt solution soaked tissue wrapped around the gage section.

Corrosion fatigue testing was performed in a medium of neutral 3.5% NaCl salt solution prepared with de-ionized water. Filter papers were soaked with the solution, wrapped around the gage section of the fatigue test specimen, and sealed with a plastic film to avoid evaporation. Figure 3 shows a specimen with the salt solution soaked filter paper sealed around the gauge section. To simulate FOD, a semi-elliptical surface notch of depth of $a_0=0.020$ in. (0.5 mm) and surface length of $2c_0=0.060$ in. (1.5 mm) was introduced in selected groups of specimens by electrical discharge machining (EDM), as shown in Figure 4. Figure 5 shows the specimen mounted in the four-point bend fixture assembled for fatigue testing in a Sonntag SF-1U HCF machine. The following table describes the test conditions used in this study:

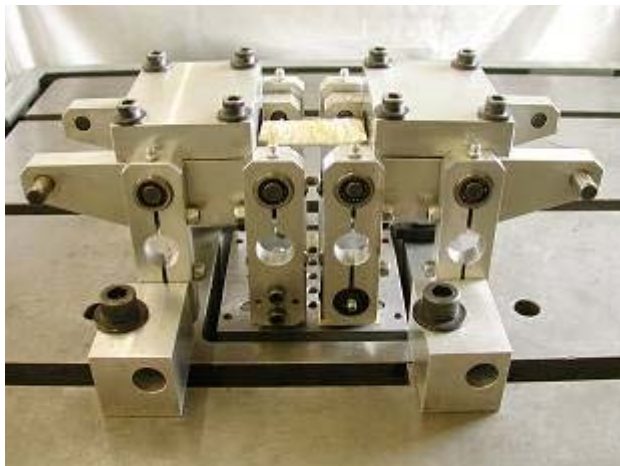
FIGURE 5 - Fatigue test set up.

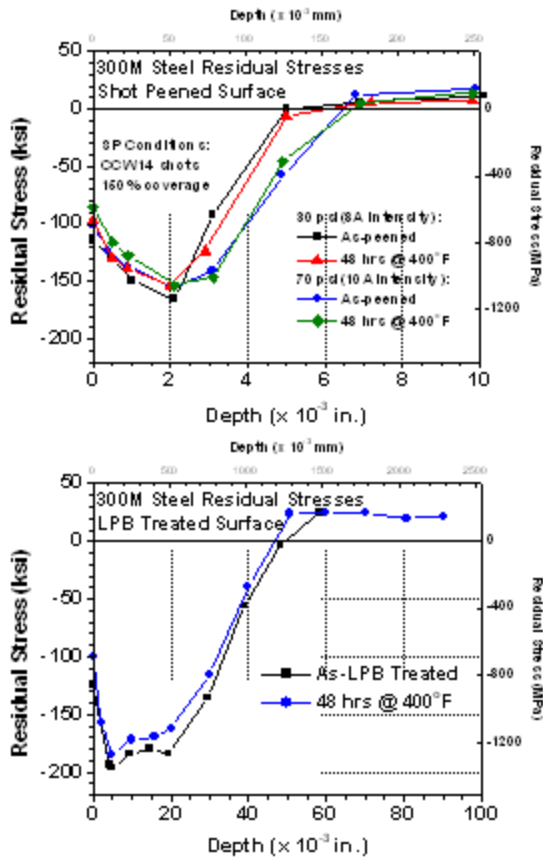
FIGURE 7 – Residual stress distribution for SP and LPB processed specimens. Thermal exposure at 400°F showed no significant effect on residual stresses.

The residual stress distributions measured as functions of depth are presented graphically in Figure 7. Compressive stresses are shown as negative values, tensile as positive, in units of ksi (10^3 psi) and MPa (10^6 N/m²).

SP treatment at 8A intensity shows surface compression in the range of -100 to -115 ksi (-690 to -790 Mpa), which becomes more compressive to about -150 ksi (-1035 Mpa) at a depth of about 0.002 in. (0.05 mm), and rapidly relaxes to nearly zero at a depth of about 0.005 in. (0.125 mm). The 10A intensity of peening produced slightly deeper compression to a depth of 0.007 in. (0.18 mm). The residual stresses from both the SP treatments did not relax significantly after thermal exposure to 400°F for 48 hours. LPB treatment produces surface compression of -100 ksi (-690 Mpa), increasing to about -180 ksi (-1240 Mpa) at depths of 0.005 to 0.020 in. (0.125 to 0.5 mm), and gradually decreasing to zero at a depth of about 0.050 in. (1.25 mm). Again, thermal exposure to 400°F for 48 hours did not result in significant relaxation of residual stresses.

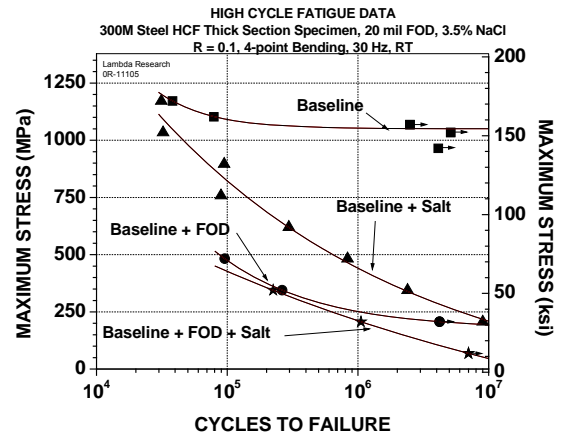
FIGURE 8 – Baseline fatigue results.

In Figure 8, the baseline material performance with and without the EDM notch and exposure to the corrosive environment is presented. The unnotched baseline condition shows a fatigue strength (endurance limit at 10⁷ cycles) of nominally 150 ksi (1035 MPa). In the presence of a neutral 3.5% salt solution, the corrosion fatigue strength for baseline drops dramatically to only 30 ksi (205 MPa). Although the baseline material exhibited a strong endurance limit behavior, the endurance limit behavior was lost in the presence of salt solution, indicating further loss of strength with increasing time and cycles. Introduction of a semi-elliptical EDM notch 0.020 in. deep drastically decreases the fatigue strength to about 30 ksi (~140 MPa) in air, and to less than 10 ksi (70 MPa) in the salt solution. Power law lines were fitted to the data in Figure 8, and represent the average behavior of the material in its baseline condition.

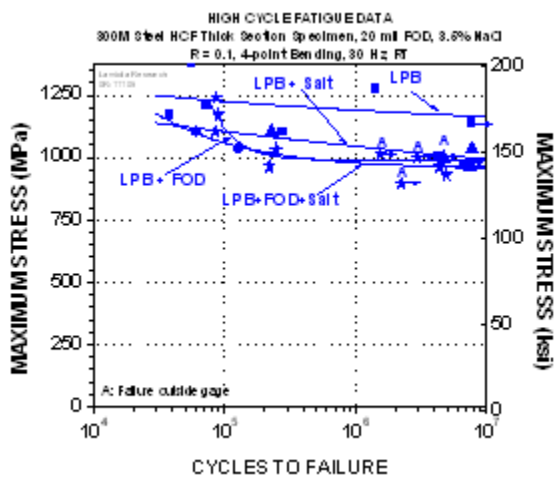
FIGURE 10 – Fatigue results for LPB

Figure 10 shows the HCF and corrosion fatigue behavior of LPB treated specimens. The unnotched specimen shows superior HCF performance, with a fatigue strength of 175 ksi (1200 MPa). Figure 10 also shows the fatigue data from all of the other test conditions with LPB treatments, notched HCF and both notched and unnotched corrosion fatigue test results, may be grouped into one set of data at a fatigue strength of 145 ksi (1000 MPa), just slightly lower than the baseline material. Three conclusions may be reached from this data. First, the LPB process has effectively mitigated corrosion fatigue. Second, the HCF and corrosion fatigue performance of this group is statistically similar to the unnotched baseline material. Third, the endurance limit behavior that was absent in both baseline and SP treatment when tested in the neutral salt solution environment is restored with the LPB treatment, an important finding for legacy aircraft operated at extended lives.

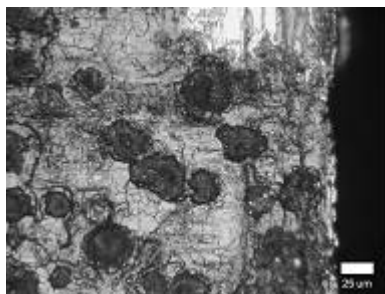
FIGURE 13 - (a) Fracture surface showing crack initiation (arrow) from a corrosion pit, (b) gage surface of the specimen showing a typical set of corrosion pits, and (c) cross-sectional view of a typical corrosion pit in a corrosion fatigue tested baseline specimen; S/N 97, $S_{max}=50$ ksi, $N_f=2.4(10^6)$ cycles (~24 hours)

Fractographic analyses presented in Figures 13, 14 and 15 are limited to unnotched corrosion fatigue tested specimens with baseline, SP, and LPB conditions. Fractographic analyses of the notched and other HCF test conditions yielded results that are expected and consistent with the fatigue test results shown in Figures 8-11, and therefore are not further described. Figure 13a shows the fracture surface of a baseline specimen with a single crack initiation site near the corner of the trapezoidal cross-section. Figures 13b and c show the role of corrosion pits on the crack initiation process.

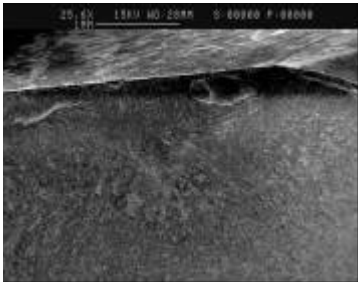
FIGURE 15 - (a) Optical fractograph showing subsurface crack initiation (arrow) site, (b) SEM fractograph showing the same region, (c) gage surface corrosion pits and cracking, and (d) cross-sectional view of a typical corrosion pit in a corrosion fatigue tested LPB specimen; S/N 11, $S_{max}=150$ ksi, $N_f=7.1(10^6)$ cycles (~70 hours)

In contrast, for LPB specimens, despite the higher stress levels and deeper corrosion pitting damage due to the longer exposure time during testing, the corrosion fatigue performance is minimally affected. This is seen in Figures 15a and b, where subsurface crack initiation is evident despite the presence of deep corrosion pits similar to the one seen in the cross-sectional view in Figure 15d.
