REDUCING CORROSION FATIGUE AND SCC FAILURES IN 300M STEEL LANDING GEAR USING LOW PLASTICITY BURNISHING

Doug Hornbach and Paul Prev y
Lambda Technologies

Copyright   2007 SAE International

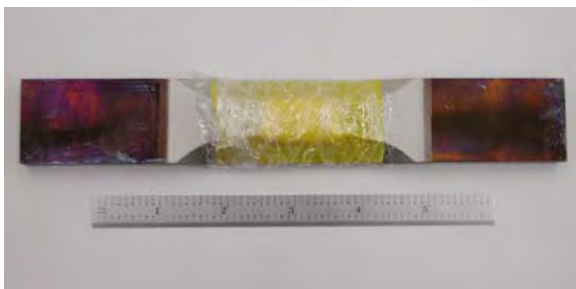
FIGURE 3 - A thick section specimen with 3.5% salt solution soaked tissue wrapped around the gage section.

HCF tests were performed under constant amplitude loading on a Sonntag SF-1U fatigue machine at ambient temperature (~72F) in four-point bending mode. The cyclic frequency and stress ratio, R ($\sigma_{min}/\sigma_{max}$), were 30 Hz and 0.1 respectively. Corrosion fatigue testing was performed in neutral 3.5% NaCl salt solution prepared with de-ionized water. Filter papers were soaked with the solution, wrapped around the gage section of the fatigue test specimen, and sealed with a plastic film to avoid evaporation. Figure 3 shows a specimen with the salt solution soaked filter paper sealed around the gauge section.

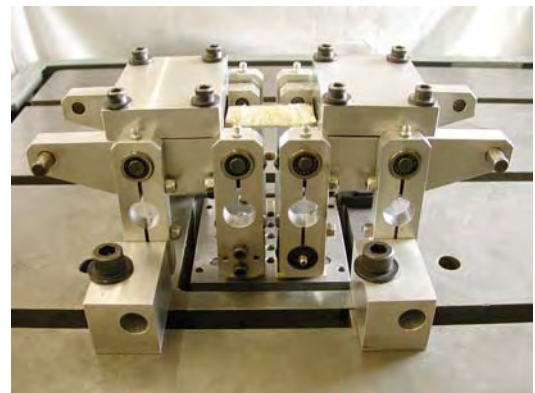
FIGURE 5 - Fatigue test set up.

FOD was simulated with a semi-elliptical surface EDM notch as shown in Figure 4. Figure 5 shows the specimen mounted in the four-point bend fixture assembled for fatigue testing in a Sonntag SF-1U HCF machine. The following table describes the test conditions used in this study:

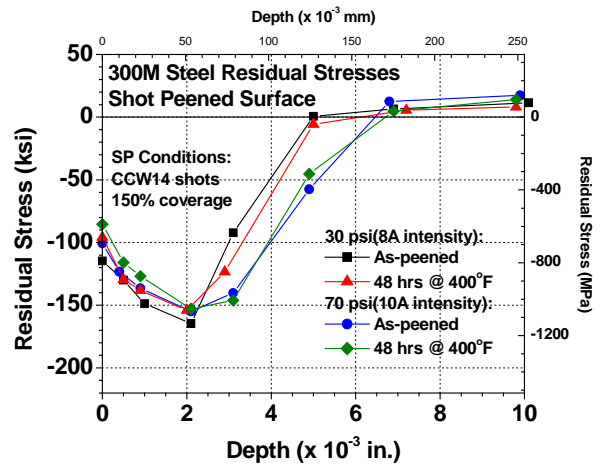
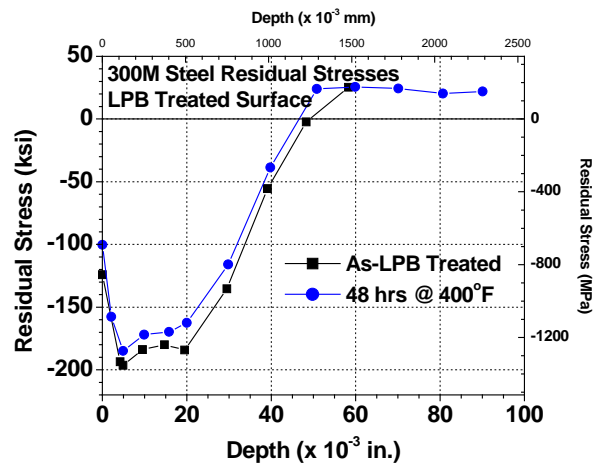
FIGURE 7 - Residual stress distribution for SP and LPB processed specimens. Thermal exposure at 400°F showed no significant effect on residual stresses.

The residual stress distributions measured as functions of depth are presented graphically in Figure 7. Compressive stresses are shown as negative values, tensile as positive, in units of ksi (10^3 psi) and MPa (10^6 N/m²). Compared to SP, LPB produced compressive residual stress of greater magnitude, nominally -1033 MPa (-150 ksi) for SP vs. -1240 MPa (-180 ksi) for LPB with an order of magnitude greater depth. Thermal exposure to 400°F for 48 hrs, simulating baking after electroplating, did not significantly relax the residual stresses from either the SP or LPB treatment.
