Safe Life Conversion of Aircraft Aluminum Structures via Low Plasticity Burnishing for Mitigation of Corrosion Related Failures

ABSTRACT

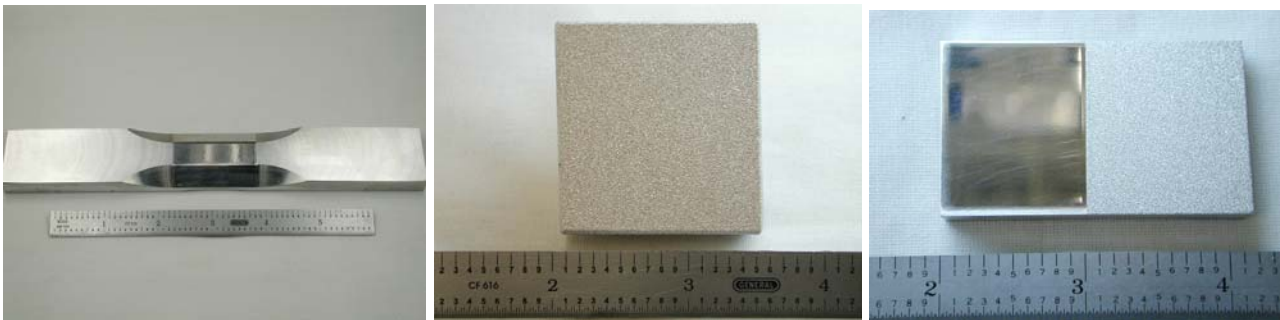
FIGURE 1 – Representative macro photos of specimen geometries tested

Material was acquired in plate form and machined into test specimens. Alloy chemistry and mechanical properties were verified for each material tested. Two specimen geometries were used in testing. Specimen Type 1 consisted of rectangular bars with an undercut trapezoidal gage region nominally 8 x 1.25 x 0.375 in. (203 x 32 x 10 mm) used for HCF/SCC testing. The trapezoidal cross section HCF sample was designed to force the fatigue failures to initiate in the compressive gage section surface under 4-point bend loading. Specimen Type 2 was a rectangular or square coupon, no larger than 2 x 2 x 0.375 in. (51 x 51 x 10 mm) used for alternate exposure testing. Figure 1 shows an example of each specimen type.

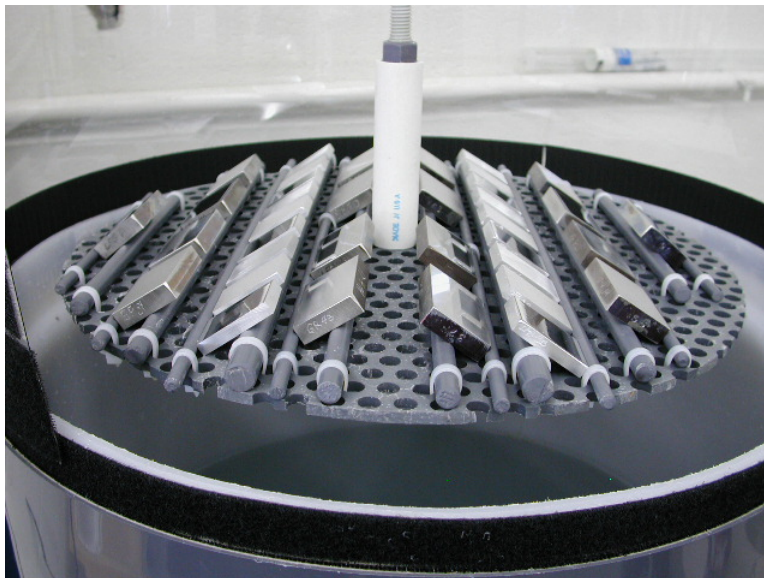
FIGURE 2 – Alternate immersion apparatus loaded with type 2 test samples

Alternate immersion testing was conducted in neutral 3.5 weight% NaCl solution at a constant temperature of 90°F (32°C) to determine the pit depth as a function of time. Type 2 coupons were tested in the following conditions: As-Machined 400 grit polish, SP, and LPB conditions. Testing was conducted using an automated alternate immersion tank shown in Figure 2 below. Samples were immersed in solution for 10 minutes and exposed to air for 50 minutes of a 1-hour cycle. All testing was performed under the guidelines and standards of ASTM G-44. A specimen of each surface treatment was removed and evaluated after 300, 500, 1000, 1500 and 2000 hours of exposure. Samples were cleaned and preserved in a sealed storage bag with silica gel desiccant to ensure no further corrosion in storage. Pit depths were using a Zeiss optical microscope at a magnification of 320X. Pit depths were plotted as a function of exposure time to determine the average pit depth for each surface treatment as a function of time.

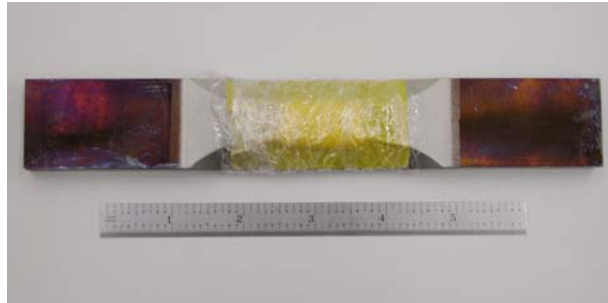
FIGURE 3 - A type 1 HCF specimen with 3.5% salt solution soaked tissue wrapped around the gage section to produce an 'active corrosion' environment during cycling

Active corrosion (AC) fatigue testing was performed in a neutral 3.5% NaCl solution prepared with de-ionized water. Filter papers were soaked with the solution, wrapped around the gage section of the fatigue test specimen, and sealed with a plastic film to avoid evaporation. Figure 3 shows a specimen with the salt solution soaked filter paper sealed around the gage section. Figure 4 shows the specimen mounted in the four-point bend fixture assembled for fatigue testing in a Sonntag SF-1U HCF machine. In this manner specimens are exposed to a corrosive environment for the duration of the HCF test.

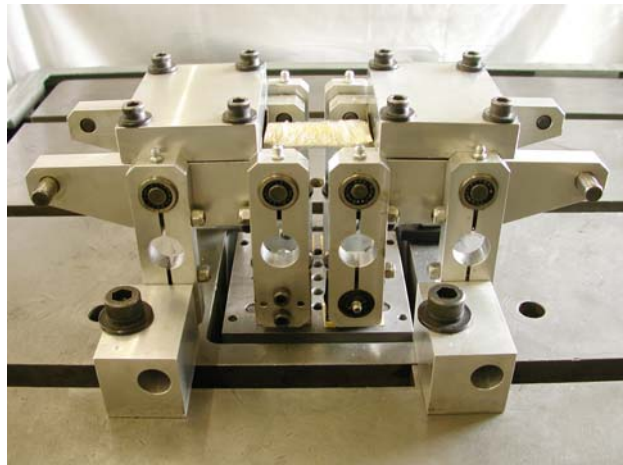
FIGURE 4 - Fatigue test set up

HCF tests were performed under constant amplitude loading on a Sonntag SF-1U fatigue machine. Fatigue testing was conducted at ambient temperature ($\sim 72^{\circ}\text{F}$ / 22°C) in four-point bending. The cyclic frequency and stress ratio, R ($\sigma_{\min}/\sigma_{\max}$), were 30 Hz and 0.1 respectively. Tests were conducted to specimen fracture or until "run-out" at 1×10^7 cycles. Specimens were subsequently broken fully open for optical and SEM fractographic analysis. Several corrosive test methods, described below, were used to damage the specimens prior to and during HCF testing to fully evaluate the benefits of SP and LPB.

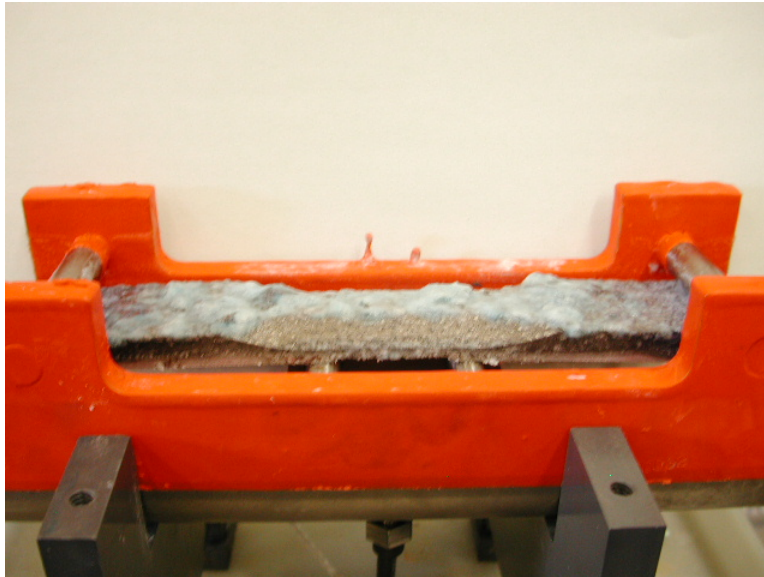
FIGURE 5 - Shot Peened SCC Sample in fixture after testing.

Specimens were tested in HCF with and without prior exposure to SCC damage to determine the effect on the subsequent fatigue life of each material. The SP and LPB surface enhancement were compared for each material. Stress corrosion cracking exposure tests were conducted according to ASTM Standard G 39 and G44-99. All exposed specimens were loaded in tension to 90% of the alloy yield strength in 4-point bending. The load was monitored continuously with load cells to detect any change in compliance. Table 1 lists the maximum stress applied for each material during SCC exposure. A loaded SCC sample is shown in Figure 5. Specimens were exposed to 3.5% NaCl solution by alternate immersion (10 minutes in and 50 minutes out per cycle). The load history on each specimen was monitored for 100 hours. The specimens were then removed, cleaned with water, and tested in HCF. Specimens were tested in isolated baths specific to each material to avoid any possible galvanic effect during the SCC exposure. Table 2 describes the HCF test conditions studied for each material. A standard reaming process was performed after SP on the AA7076-T6 specimens to simulate an additional commonly used surface treatment.

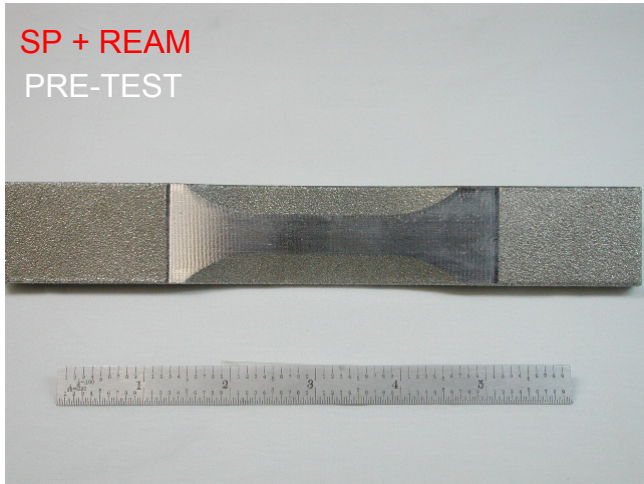
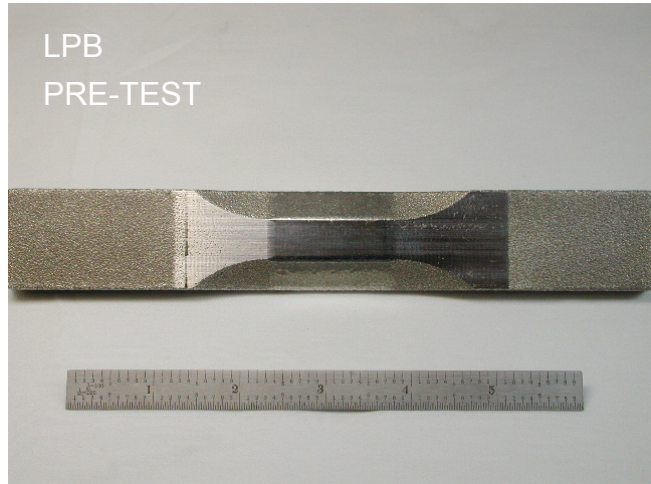
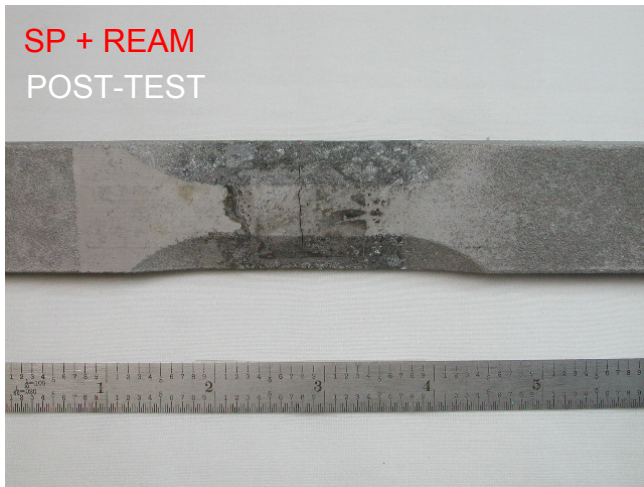
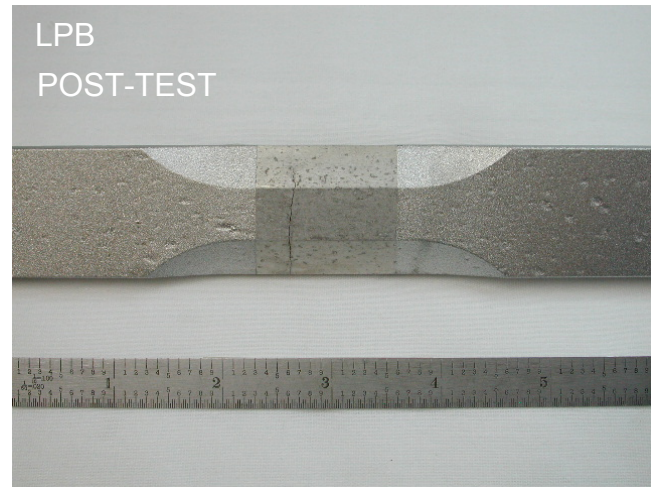
FIGURE 6 – Low magnification photos of specimens before and after exposure. SP specimens exhibited greater damage than LPB specimens.

Photographs of the surfaces of AA7076-T6 specimens before and after testing are shown in Figure 6. Figure 7 shows the pit depth and Gaussian distributions for AA7076-T6 after the full 2000-hour exposure period. SP specimens tended to have a greater overall number of pits compared to LPB processed specimens. SP specimens also had deeper pits compared to the LPB specimens, which exhibited shallow surface damage with fewer deep pits.

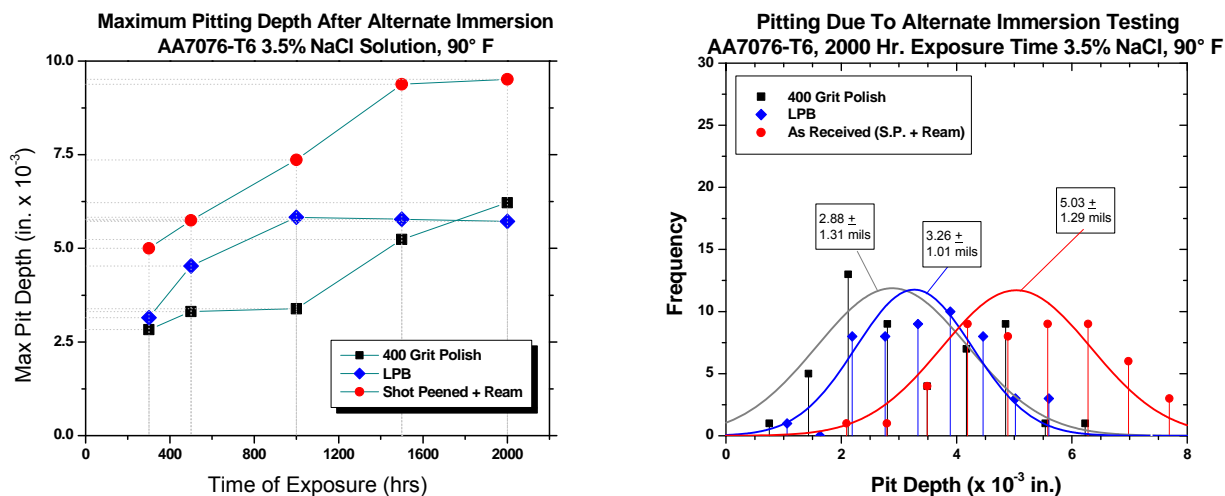
FIGURE 7 – Pit depth analysis for AA7076-T6. The plot on the left shows the pit depth as a function of time. The plot on the right is a histogram showing the distribution of pits after 2000 hrs. exposure.

It was observed from the pit depth vs. time plots that the rate of depth increase slowed as a function of time, asymptotically approaching a maximum pit depth for each alloy and condition. The maximum pit depth for the SP condition was nominally 9.5×10^{-3} in. (0.24 mm) compared to 5.7×10^{-3} in. (0.14 mm) for the LPB treatment. In all alloys tested the maximum pit depth was observed to be greater for the SP specimens. If the residual compression imparted from either SP or LPB exceeds the maximum pit depth so that the pit is held entirely in compression, then fatigue cracking cannot initiate, even with the high stress concentration due to the pit, and the likelihood of fatigue failure initiation from pitting is greatly reduced, or even eliminated if the compression is sufficient.

The pitting behavior was also plotted as histograms with a Gaussian function fit about the data. The histograms revealed the average depths for each condition as well as the minimum and maximum pit depth values for each distribution. The LPB treatment and as-machined conditions show similar behavior for all materials in alternate immersion testing. This is attributed to the lower cold working of the surface of the specimens. The LPB and as-machined conditions also both have much smoother and more uniform surface roughness than the SP specimen. The rough cold worked surface from the SP process provides a more chemically active surface that is more prone to corrosion.

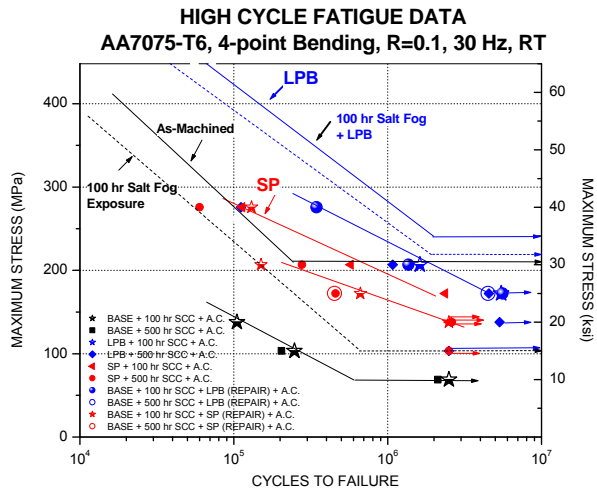
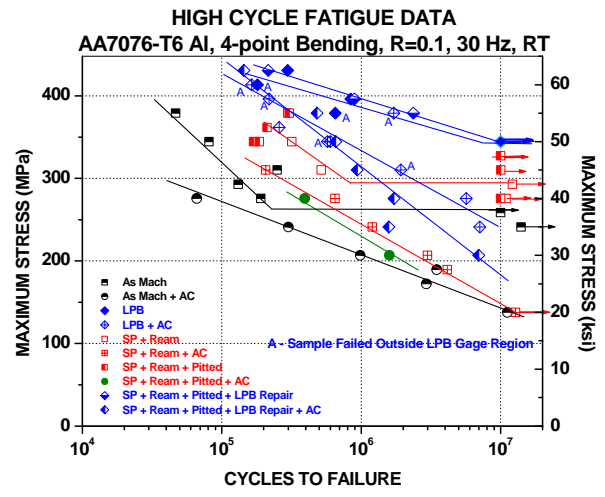
FIGURE 8 – S-N curves for AA7075-T6 (left) and AA7076-T6 (right). LPB processing showed greater than an order of magnitude improvement over the SP at most stress levels tested. LPB also increased the fatigue strength of both materials significantly.

Stress vs. Life (S-N) curves were generated for the four materials tested in the various corrosive conditions detailed in Table 2 above. To simulate both initial manufacture and repair, specimens underwent LPB or SP either before or after SCC exposure, respectively. The specimens were subsequently tested in HCF in active corrosion for the duration of the tests. To determine the full fatigue benefit of each treatment in the absence of a corrosive environment, ‘baseline’ tests were conducted with no prior corrosion or active corrosion during cycling. The pits resulting from the SCC exposure or salt fog chamber were consistent with the pit depths measured in the alternate immersion study.

The depth of compression in relation to the depth of the pits proved a critical factor. The greater depth of compression from the LPB process provided much longer fatigue life in all four alloys. Corroded LPB processed specimens exhibited fatigue life equal to, or greater than, the un-damaged as-machined specimens, and even the un-damaged SP processed specimens. The ‘baseline’ undamaged LPB curve, for all four alloys, produced the highest run-out stress and longest life of all the conditions.

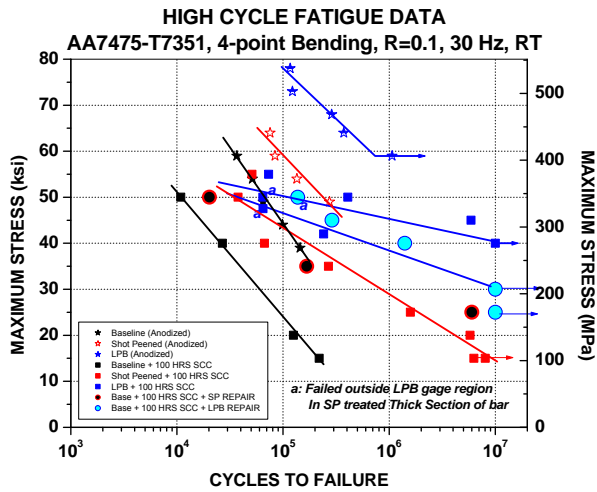
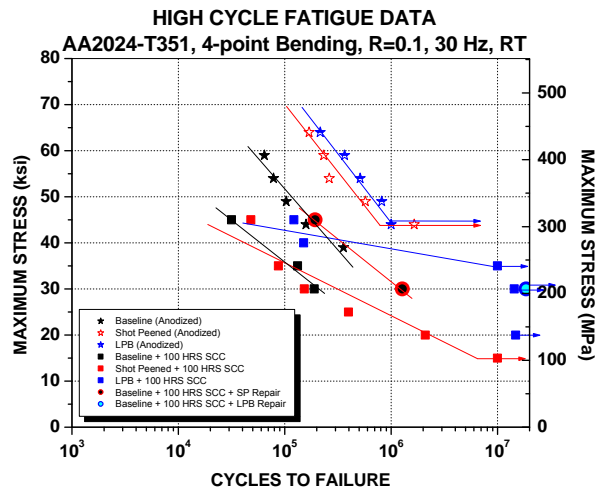
FIGURE 9 – S-N curves for AA7475-T7351 (left) and AA2024-T351 (right). The LPB process showed dramatic improvement in fatigue life and strength for both materials – particularly in the corrosion damaged conditions.

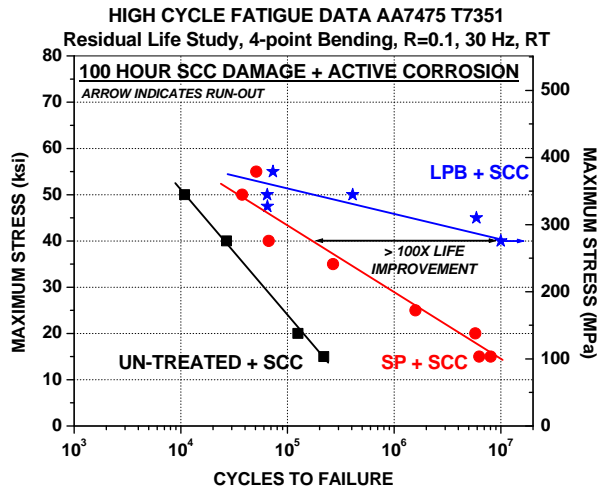
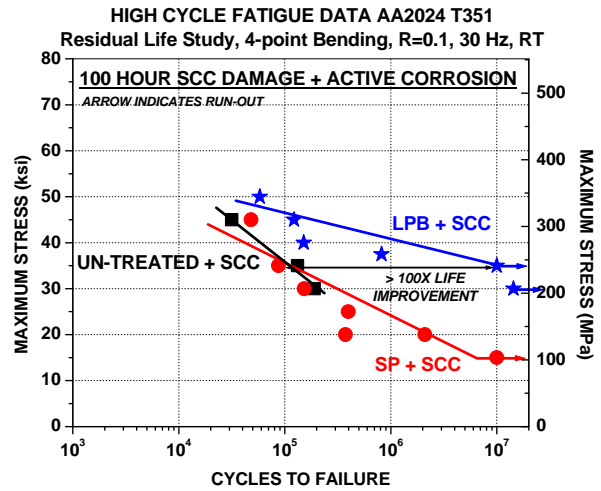
FIGURE 10 – Effect of corrosive environment on the fatigue life of 7000 and 2000 series Aluminum Alloys. The LPB treated specimens demonstrated greater than 100X increase in life over the SP treatment.

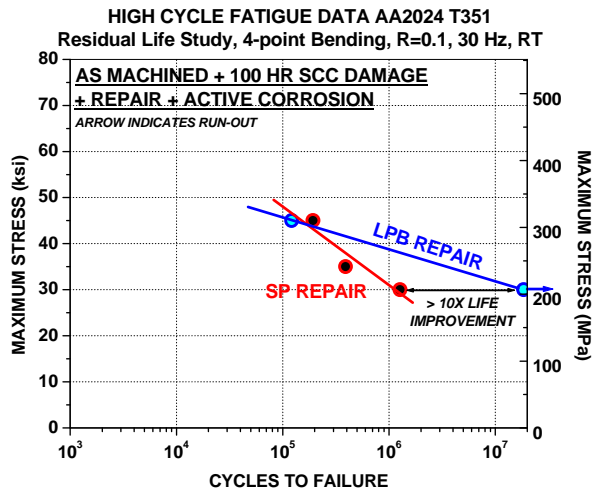
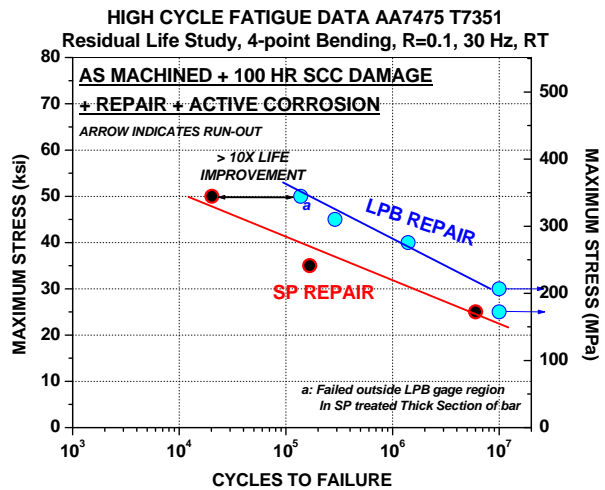
FIGURE 11 – Comparison of LPB and SP as repair processes for pre-corroded specimens. The LPB process improved the fatigue life by over an order of magnitude compared to the SP treatment.

LPB used as a repair process on as-machined + SCC exposed specimens was able to restore the fatigue life to greater than that of the SP + SCC specimens. In AA7075-T6 and AA2024-T351 the fatigue life was improved by greater than an order of magnitude over the SP repair specimens. The LPB repair processing was performed directly over the pre-corroded material with no prior cleaning other than a rinse in distilled water. Figures 8 and 9 show the full S-N curves for the alloys tested. Figure 10 shows the benefit of each surface treatment for a 7000 series alloy and 2000 series alloy when exposed to corrosion damage. The effectiveness of each treatment as a repair process is illustrated in Figure 11. The LPB process increased the fatigue life by nominally 10X over the SP treatment for all alloys tested and greater than 100X for the corrosion damaged alloys. Figure 12 is a bar chart showing the increase in fatigue strength at 1×10^7 cycles. The LPB process improved fatigue strength by 2-3X over the SP treatment under corrosive conditions.

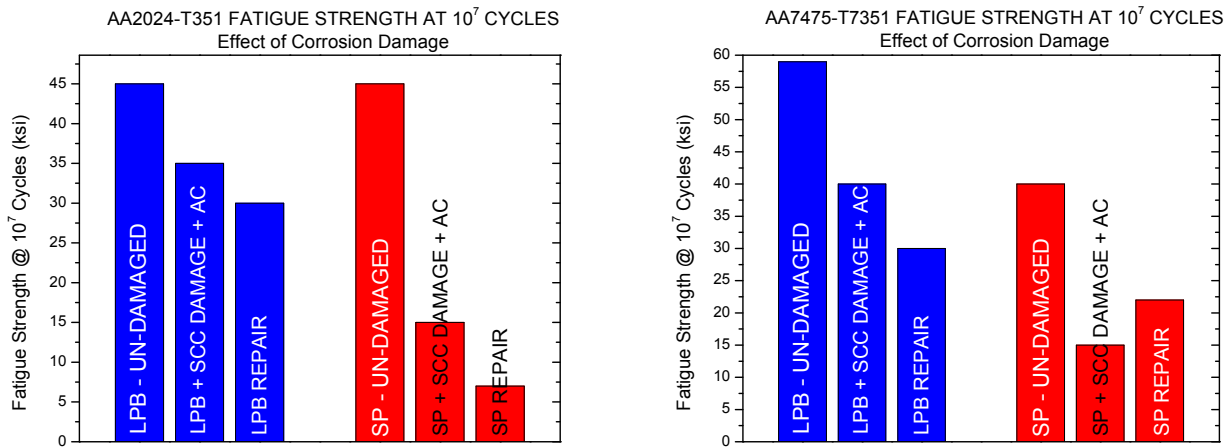
FIGURE 12 – Column plots comparing the fatigue strength at 10⁷ cycles. LPB processed specimens demonstrated an increase of 2-3X improvement over the SP treatment.

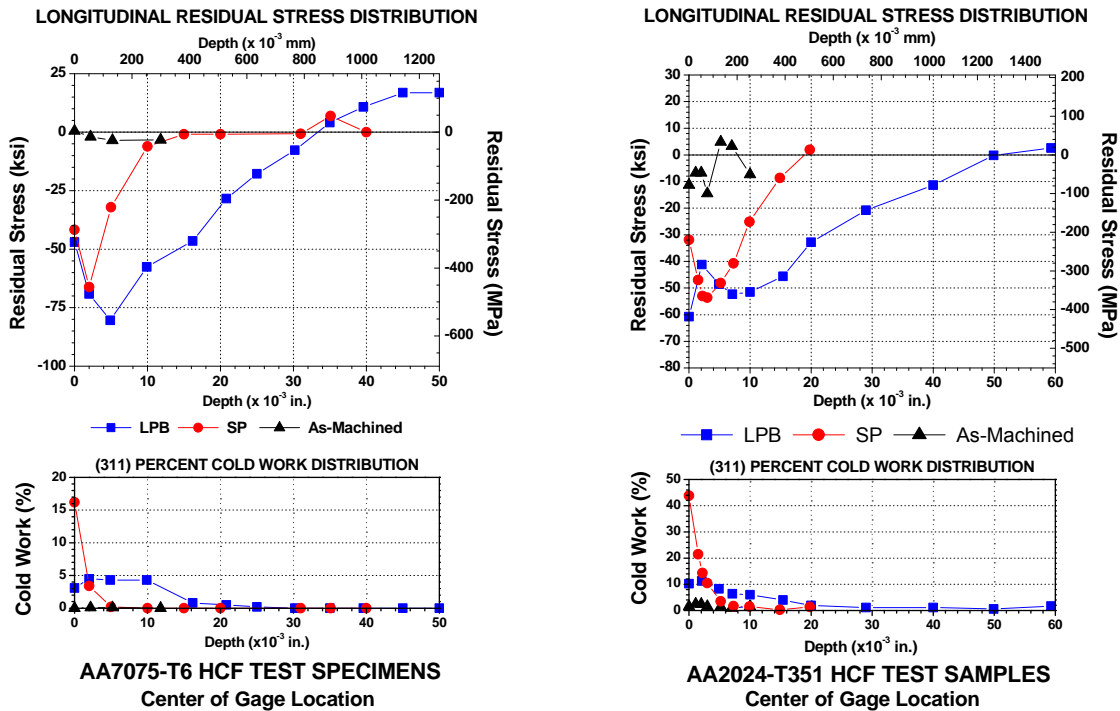
FIGURE 14 – Residual stress distributions for each surface treatment on AA7075-T6 and AA2024-T351. LPB processing provided greater magnitude and depth of compression than SP in all materials tested with low levels of cold working.

X-ray diffraction residual stress results for AA7075-T6 and AA2024-T351 are presented graphically in Figure 14 and are representative of all four materials tested. Compressive stresses are shown as negative values, and tensile stresses as positive, in units of ksi (10^3 psi) and MPa (10^6 N/m²). Compared to SP, LPB produced a compressive residual stress field in each material with a greater magnitude of compression and over 3X the depth of compression. The random impact of shot during the SP process produces multiple impacts at the same location on the specimen. This repeated plastic deformation produces high cold working. LPB produced much less cold working of the treated specimens than SP ensuring the deep compression remains stable, even at high temperature or in the case of mechanical overload. The depth of compression from the LPB process greatly exceeds the maximum pit depth observed, preventing fatigue crack initiation from pits shallower than the compressive layer. This is reflected in the improved fatigue performance shown above.
