Improving Fatigue Life of Ductile Cast Iron via Surface Enhancement

Perry W. Mason, Kyle A. Brandenburg, and Douglas J. Hornbach

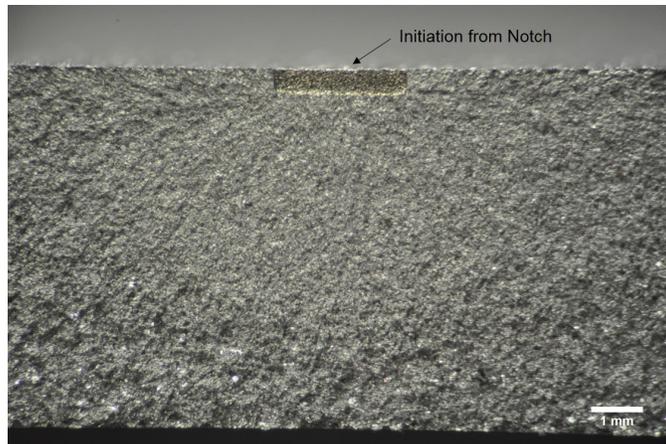
Typical fracture faces for each tested sample group are shown in Figures 11 through 15. An example of the undamaged specimen group is shown in Figure 11. Figure 12 shows an example of a fracture face of the specimens that were notched to 0.020 in. Fracture faces for samples tested in CF with and without notches are shown in Figures 13 and 14, respectively. An example of a fracture face of a CF specimen that did not fail from the notch is shown in Figure 15.

Figure 12: Fracture Face of a Shot Peened Specimen With a 0.020 in. Deep Notch

Samples with no damage failed within the gage from single surface initiations. With the exception of a few LPB samples tested in CF, samples with notch damage primarily failed from the notch. Samples tested in CF only generally failed from one dominant initiation with some additional minor surface initiations within the gage region.

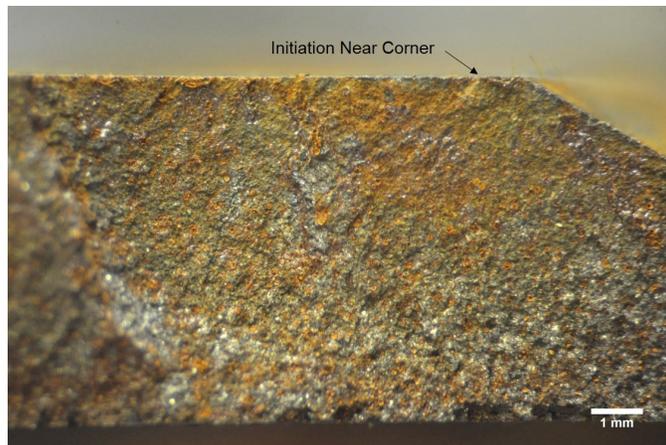
Figure 13: Fracture Face of a LPB Specimen Ran in CF
