## Engineered Residual Stress to Mitigate Stress Corrosion Cracking of Stainless Steel Weldments

Jeremy E. Scheel, N. Jayaraman, Douglas J. Hornbach  
Lambda Technologies  
5521 Fair Lane  
Cincinnati, OH, 45227-3401  
USA

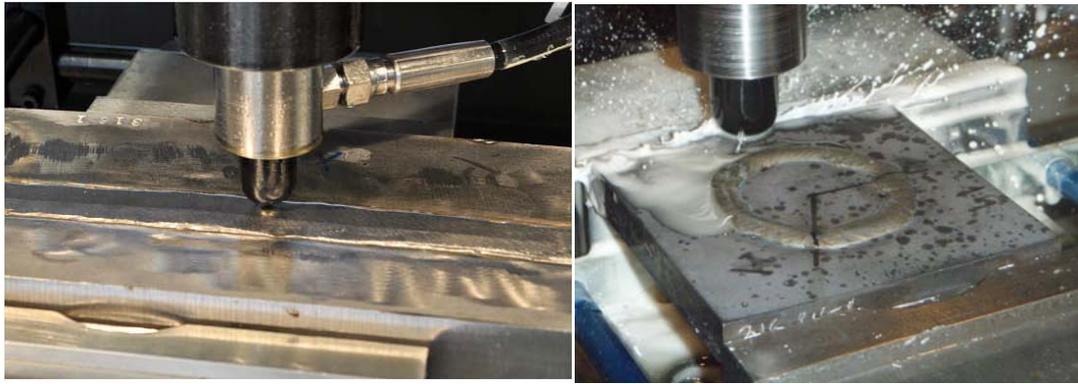
Figure 1: LPB Processing of specimens

LPB processing was performed on a 4-axis CNC mill. The square and rectangular welded plate specimens were LPB processed along half of each specimen using single point LPB tooling as shown in Figure 1. Figures 2 and 3 show both geometries after LPB processing. The sections of schedule 40 pipe were welded together using a typical butt weld then LPB processed, using a double ball caliper tool, on both the inside and outside diameters of the welded pipes. A finished pipe weld specimen is shown in Figure 4.

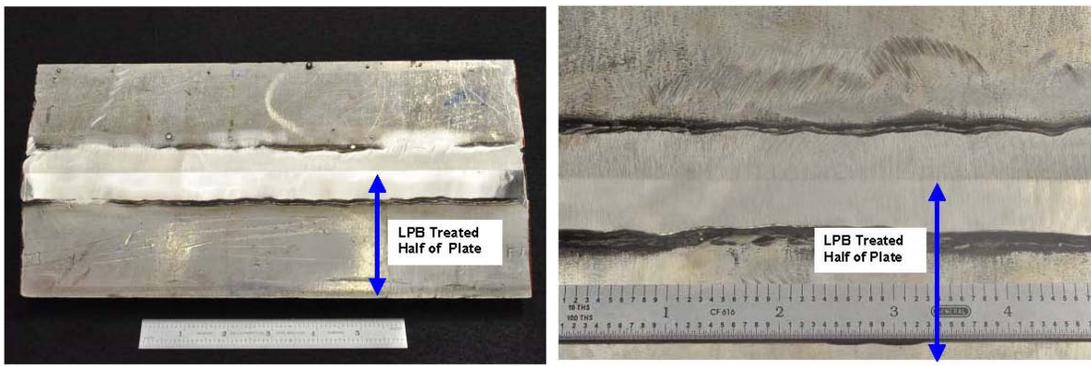
Figure 2: 304L SS Half LPB processed plate specimen.

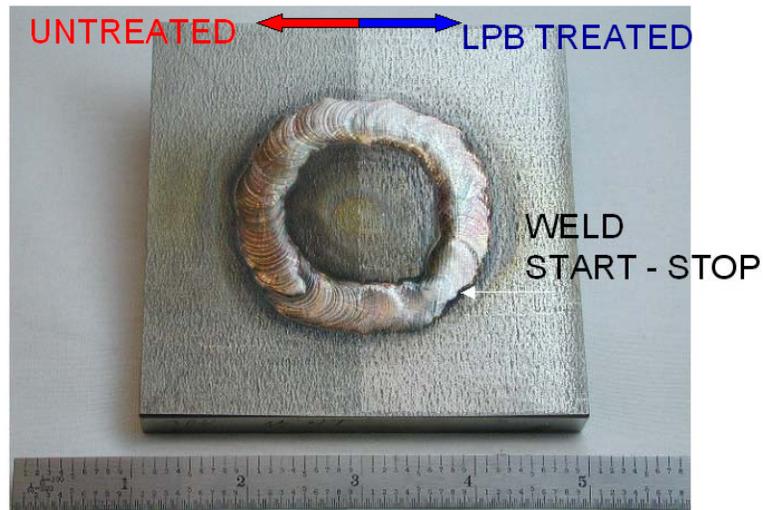
Figure 3: Half LPB processed 316L Plate Specimen

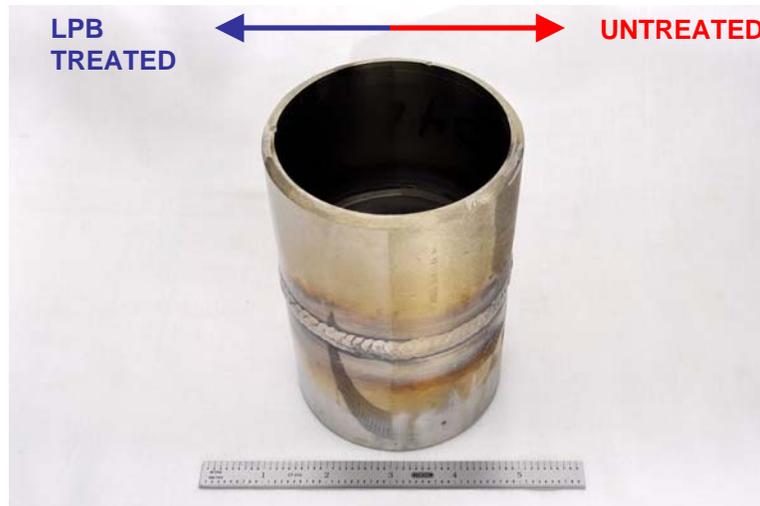
Figure 4: 304L SS circular weld plate specimen. 1/2 LPB Processed 316LSS welded pipe specimen; half LPB processed on inside and outside diameter.

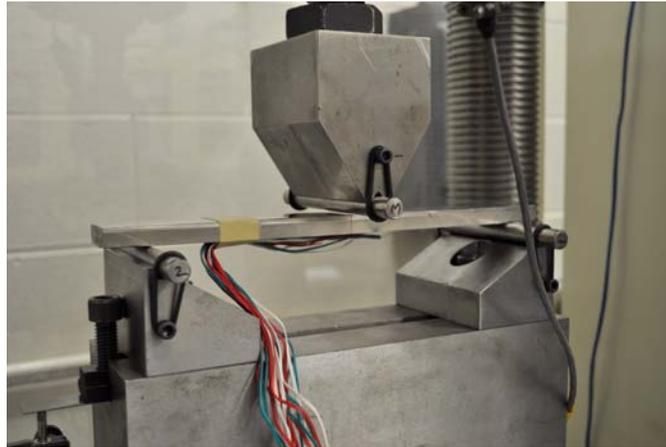
**Figure 5: Mechanical stability 3-pt bend test sample mounted in loading fixture on a hydraulic loading frame.**

Separate test specimens were specifically machined in order to characterize the mechanical stability of the LPB induced compressive residual stress. Test samples with dimensions of 0.625 x 1.25 x 12 in. (15.9 x 31.8 x 304.8 mm) were manufactured from 304L and 316L SS. The test specimens were LPB processed on the active faces. Following LPB treatment the specimens were instrumented with strain gage rosettes to monitor the strains applied via 3-point bending. A picture of a sample mounted in the 3-point bend fixture on the hydraulic test frame is shown in Figure 5.

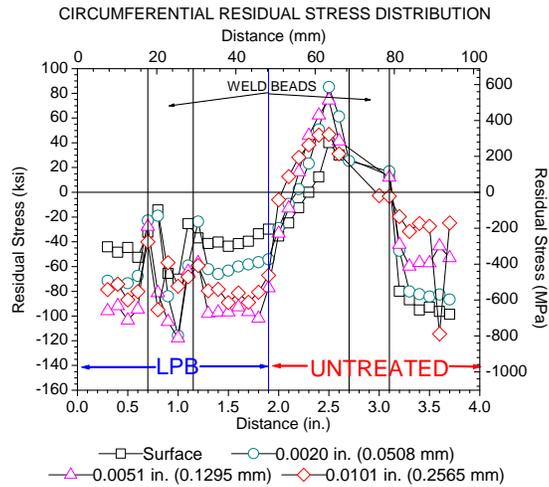
Figure 6: XRD residual stress measurements on half LPB treated welded 304L SS plate. The LPB processed region is in deep compression across the weld while the untreated half is in high tension.

Figure 5 shows the residual stress distribution as a function of distance and depth for a 304L circular welded plate in both the LPB treated and un-treated regions. Tensile residual stresses on the as-welded side of the sample approach +100 ksi (+689 MPa). The LPB treatment produced deep compression with a magnitude of greater than -120 ksi (-827 MPa). Figure 6 shows the residual stress distribution as a function of distance and depth for a 316L welded rectangular plate in both the LPB treated and un-treated regions. Tensile residual stresses on the as-welded side of the sample exceed +100 ksi (+689 MPa). The LPB treatment produced deep compression with a magnitude of greater than -90 ksi (-620 MPa).

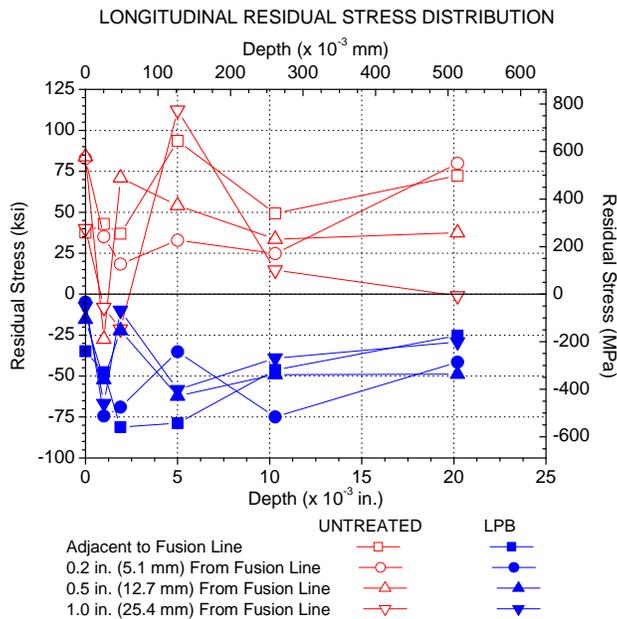
Figure 7: Longitudinal residual stress vs. depth on a 316L welded plate. The LPB processed half remains in a compressive state out past 1.0 in from the fusion line. High magnitude tensile stress is present on the untreated half of the plate.

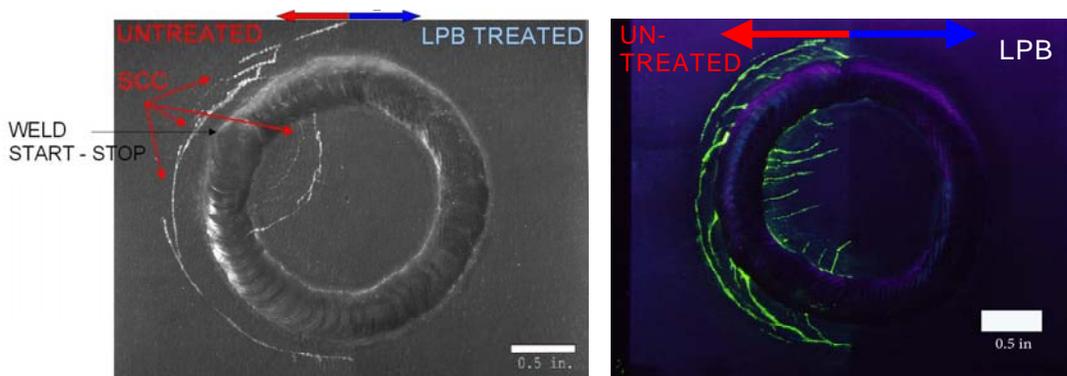
**Figure 8: Black light fluorescent dye defines severe SCC on un-treated side of 304L (left photo) and 316L SS circular weld (right photo) specimens.**

Photographs shown in Figure 7 show a 304L and 316L SS circular weld specimen after 100 hours exposure to hot/boiling  $MgCl_2$  above 120° C. The extent of the damage on the untreated half of the specimens is obvious. Cracking is observed in both the hoop and radial directions and is a direct result of the tensile stress field on the untreated material; the cracking terminates precisely at the boundary of the LPB processing. Figure 8 shows a cross section of a 304L specimen revealing through thickness cracking on the untreated material. Figures 9 – 13 show the SCC damage sustained by the rectangular welded specimens after 100-hour exposure in  $MgCl_2$ . Again the untreated material suffered severe SCC damage. Areas of grinder burn were also initiation points for SCC on the unprocessed half of the specimen. LPB prevented this on the processed halves which also had grinder burns. Cross sectional examination of the specimens reveal the depth of the cracking extends approximately 0.5 in and terminates near the toe of the weld.

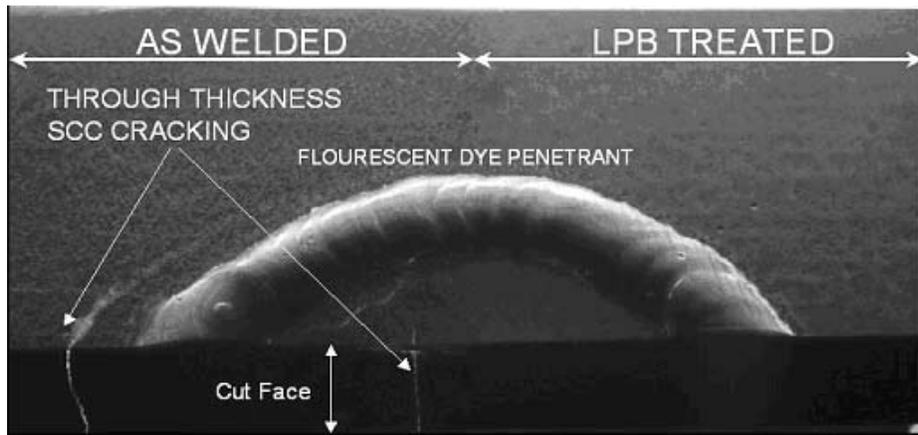
Figure 9: Fluorescent dye penetrant photo showing through thickness SCC cracking on untreated side of 304L SS circular weld specimen.

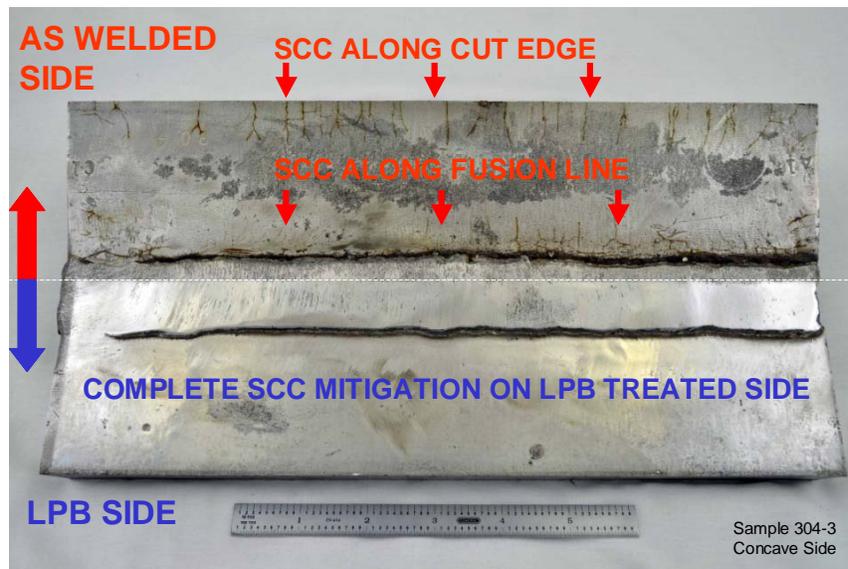
## POST SCC TESTING - 304

Figure 10: Sample 304-3 following  $MgCl_2$  exposure showing severe SCC on untreated concave side and no SCC on LPB treated side of plate.

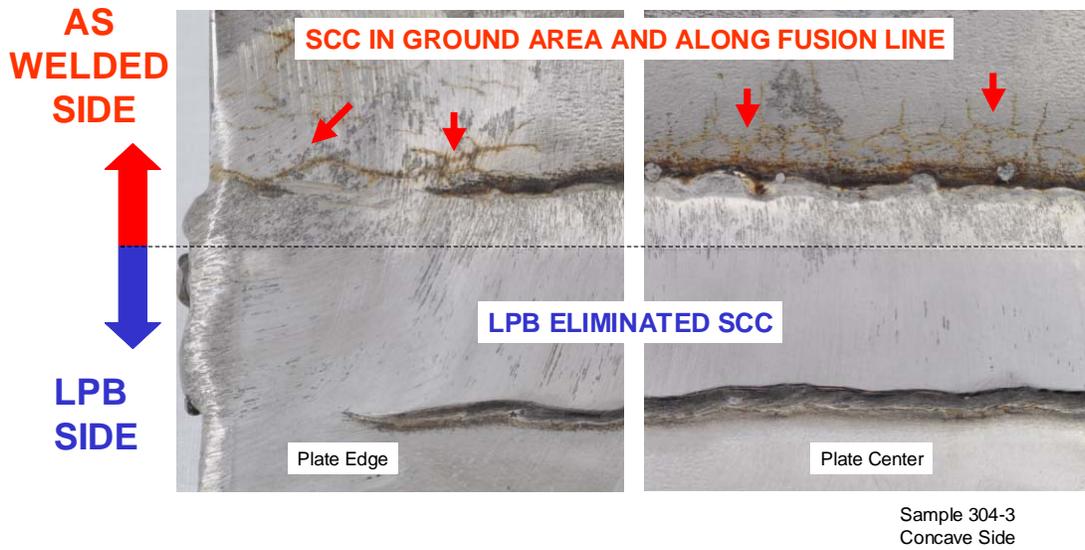
# POST SCC TESTING - 304

Figure 11: Close-up of Sample 304-3 fusion line on concave side following  $MgCl_2$  exposure showing extensive SCC in ground region and along fusion line on untreated region.

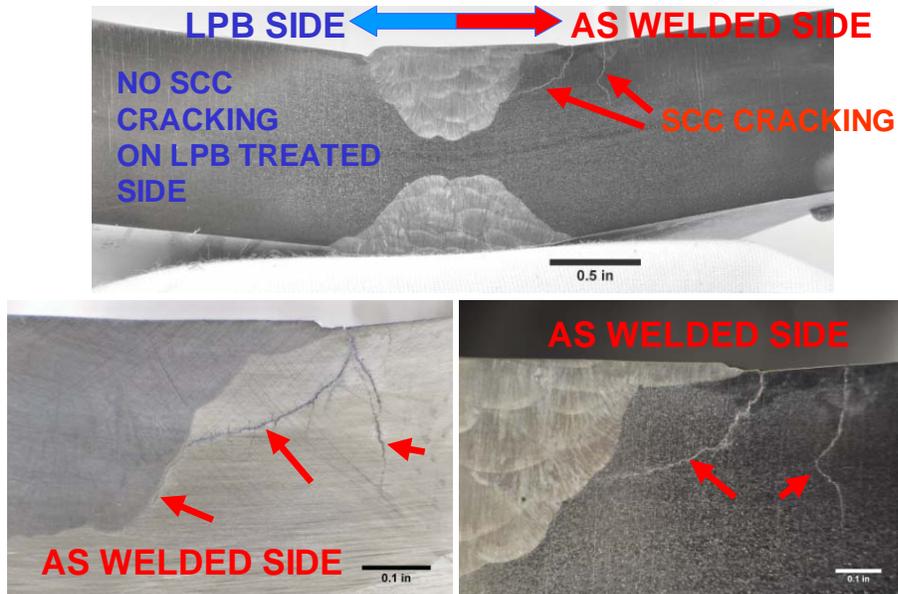
# POST SCC TESTING - 304

Figure 12: Cross section of Sample 304-3 showing deep SCC in heat affected zone on untreated side of test plate and no SCC on LPB treated side of plate.

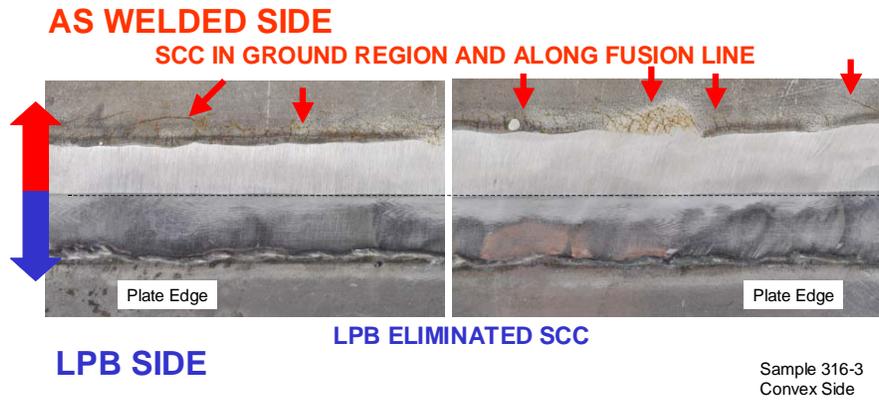
# POST SCC TESTING - 316

Figure 13: Close-up of Sample 316-3 fusion line on convex side following  $MgCl_2$  exposure revealing SCC along fusion line and in ground regions on untreated side and no SCC on LPB side.

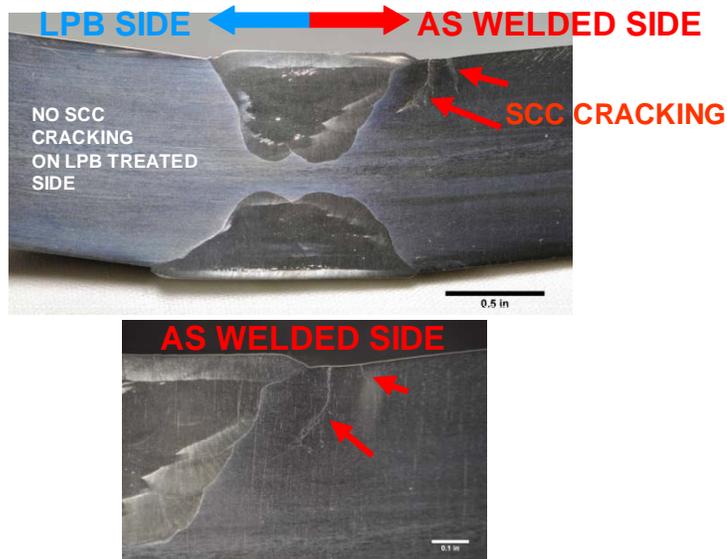
# POST SCC TESTING - 316

Figure 14: Cross section of Sample 316-3 showing deep SCC in heat affected zone on untreated side of test plate and no SCC on LPB treated side of plate.

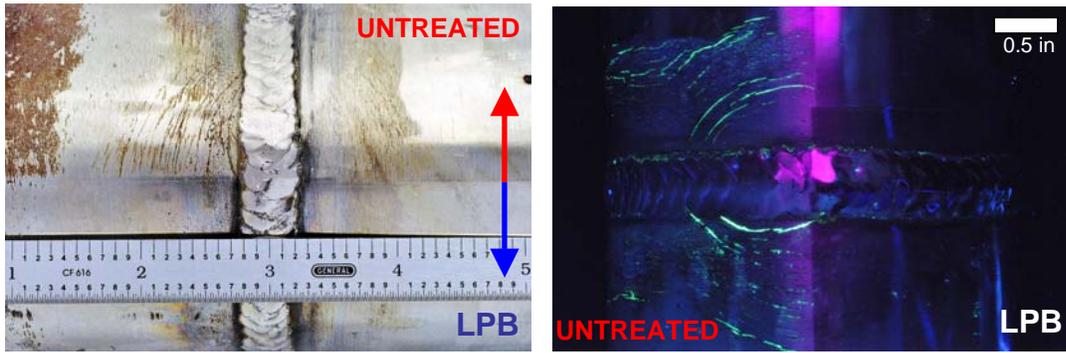
Figure 15: SCC cracking on un-treated side of a 304L SS pipe weld specimen. The photo on the right is a fluorescent dye image of the same specimen shown on left. No cracking was found on the LPB processed regions any specimens.

Figure 14 shows a 304L pipe weld specimen after 24 hours of  $MgCl_2$  exposure. The untreated material again exhibited severe through thickness SCC cracking. Examination of all tested samples revealed no evidence of SCC on the compressive LPB processed side. The un-processed side of all specimens tested developed extensive SCC.

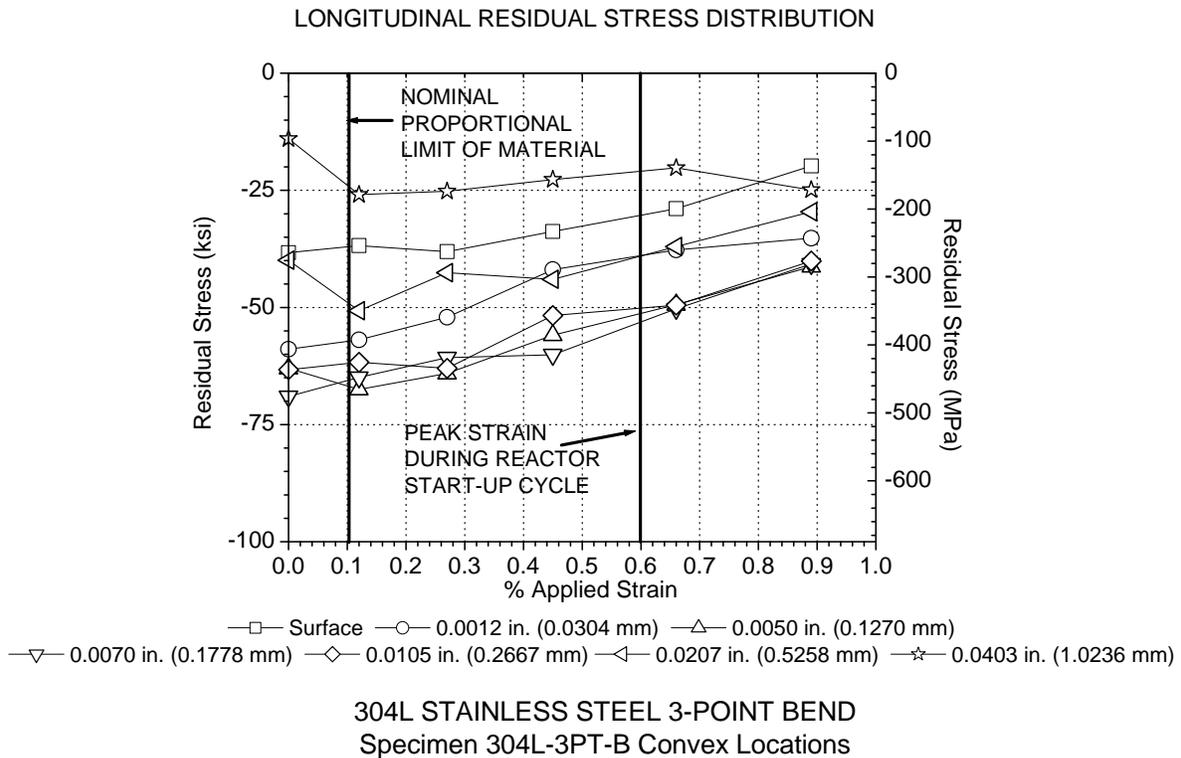
Figure 16: Longitudinal residual stress on 304L 3 point bend sample.

Figures 16 and 17 show the resulting residual stress distributions for each alloy after mechanical stability testing. The compression from LPB shows only a small reduction in magnitude even at applied strains well above the proportional limit of the material. During the initial reactor start-up cycle dissimilar butt weld joints may experience total strains as high as 0.6%, which is well into the plastic regime for the alloys studied.

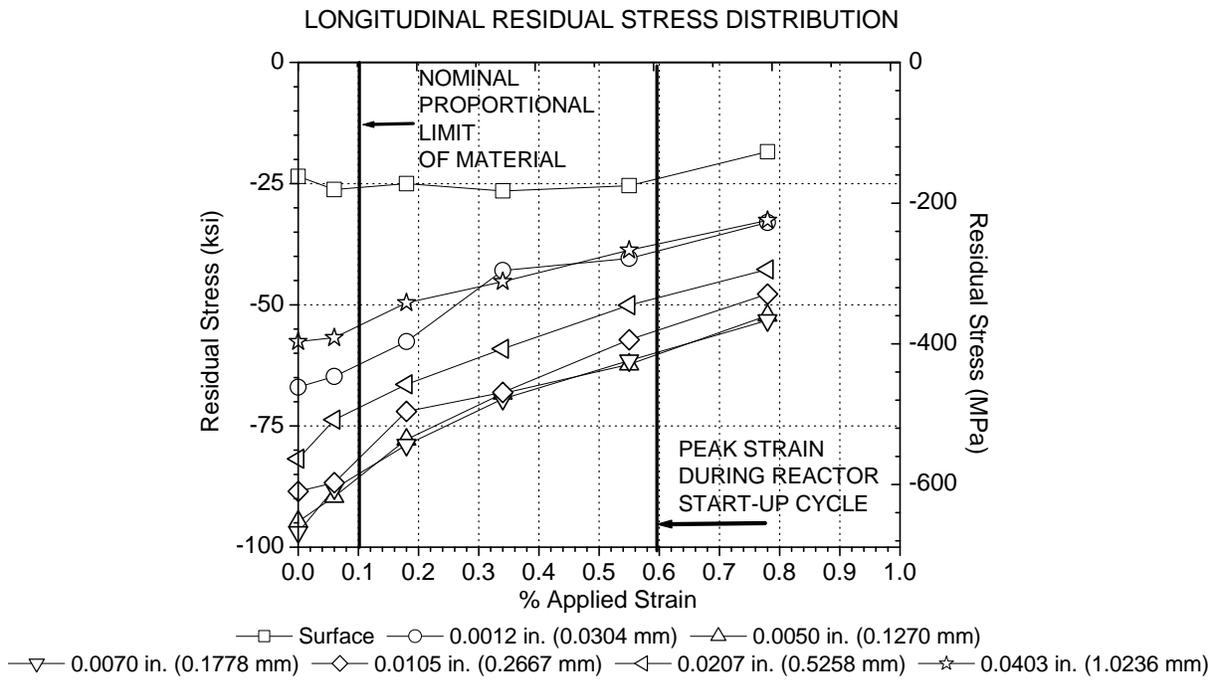
316L STAINLESS STEEL 3-POINT BEND  
Specimen 316-3PT-B Convex Locations

**Figure 17:— Longitudinal residual stress on 316L 3-point bend sample.**

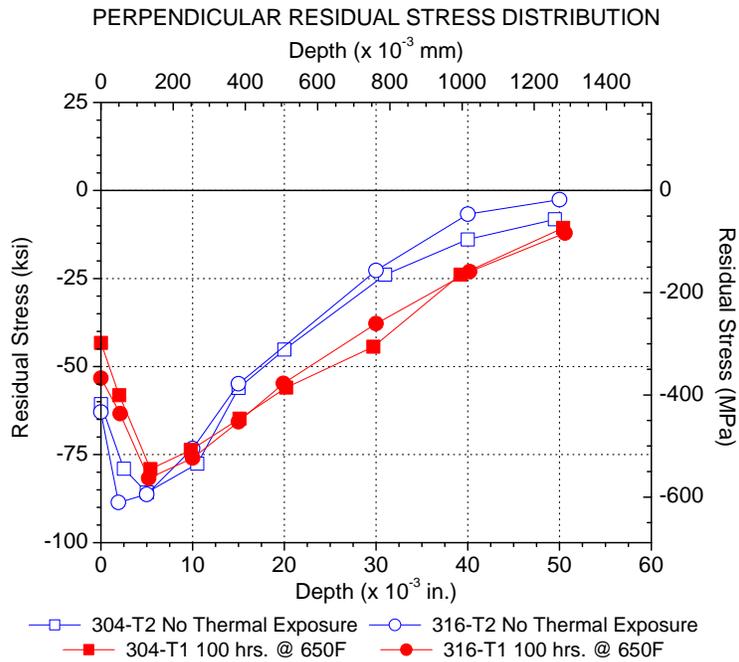
STAINLESS STEEL LPB PROCESSED PLATES  
Center of LPB Processed Region

**Figure 18: Residual stress vs. depth for both thermally treated specimens and unexposed baseline specimens.**

Figure 18 shows the residual stresses as a function of depth. Depth of compression resulting from LPB is on the order of 0.05 in. Results indicate only a slight reduction in near surface compression as a result of the thermal exposure.

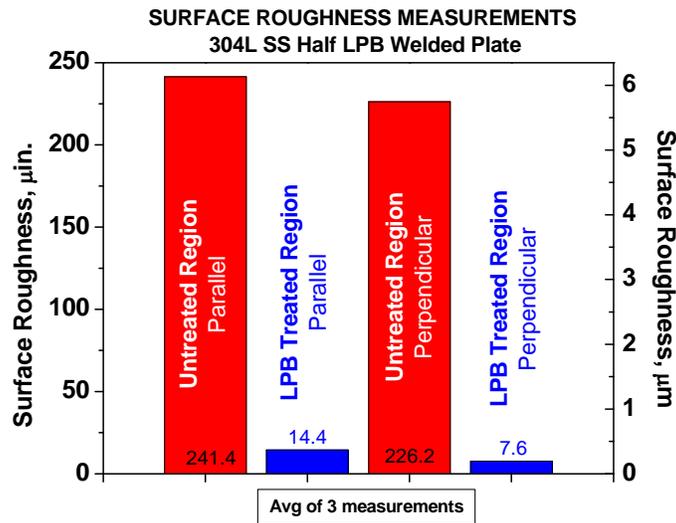
Figure 19: Average Ra surface roughness of specimen on un-treated and LPB treated regions. LPB produced a greatly improved surface finish with an average improvement of 95% Ra.

Surface roughness results are presented graphically in Figure 15. The LPB treatment dramatically improved the surface finish. Surface roughness in the parallel and perpendicular direction was reduced on average by nominally 95% due to LPB. The smoother surface finish produced by LPB is understood to be beneficial in non-destructive examination.
