THE EFFECT OF SURFACE ENHANCEMENT ON IMPROVING THE FATIGUE AND SOUR SERVICE PERFORMANCE OF DOWNHOLE TUBULAR COMPONENTS

Jeremy E. Scheel and Douglas J. Hornbach
Lambda Technologies
Cincinnati, OH 45227, USA

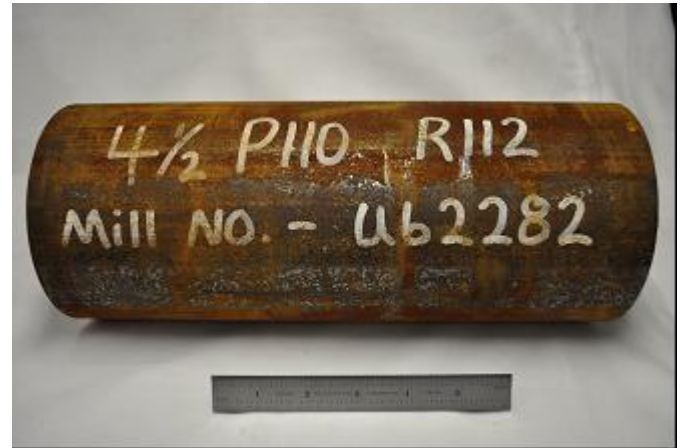
C- ring specimens used for fatigue and SSC testing were taken from API P110 grade quench and tempered coupling stock with 4.5 in. (114.3 mm) ID and 0.25 in. (6.4 mm) wall thickness. C- ring samples were made per NACE TM0177-Method C. SSC tests were also conducted on full size coupling stock. An example of the coupling stock is shown in Figure 1. The chemistry and mechanical properties were verified and are shown in Tables I and II, respectively.

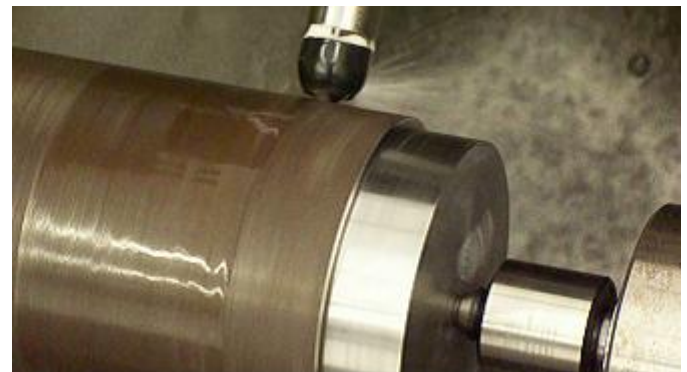
LPB process parameters were developed to impart a depth and magnitude of compression sufficient to mitigate SSC and the simulated damage during HCF testing with minimal cold work. Figure 2 shows a API-P110 coupling being LPB treated on a CNC lathe with a single point LPB tool.

FIGURE 2: API-P110 COUPLING BEING LPB PROCESSED ON A CNC LATHE

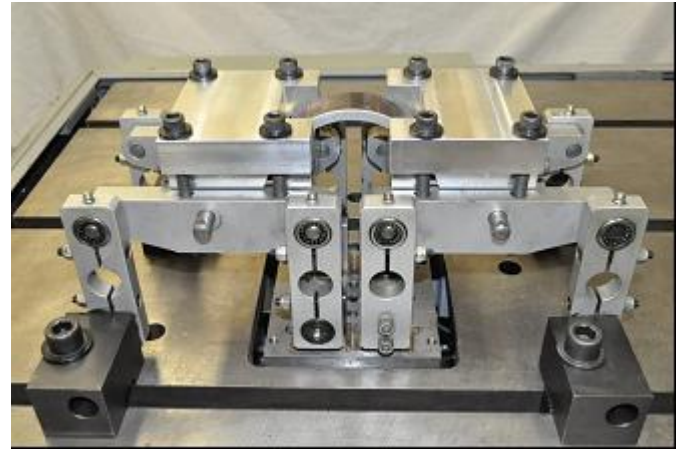
HCF tests were performed under constant amplitude loading on a Sonntag SF-1U fatigue machine. A photo of the fatigue setup is shown in Figure 3. Specimens were tested in the untreated and LPB conditions with and without mechanical EDM or corrosive damage. Fatigue testing was conducted at ambient temperature ($\sim 72^\circ\text{F} / 22^\circ\text{C}$) in four-point bending. The cyclic frequency and stress ratio, R ($\sigma_{\min}/\sigma_{\max}$), were 30 Hz and 0.1 respectively. Tests were conducted to specimen fracture or until "run-out" at 1×10^7 cycles. Specimens were subsequently broken open for optical and SEM fractographic analysis.

FIGURE 3: HIGH CYCLE FATIGUE TEST SET UP

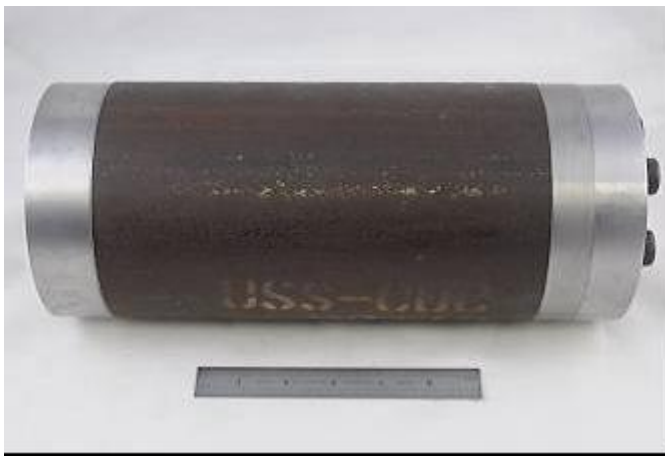
Testing of full size coupling blanks was performed using a custom made holding fixture connected to a pressurizing test station. The full sized coupling blanks were internally pressurized hydraulically to impart the desired amount of applied hoop stress. Test solution was monitored for pH and refreshed as needed to conform to the NACE TM0177 standard. Testing was conducted until specimen failure or a run out life of 720 hours (30 days) or more was achieved per NACE TM0177 standard. Specimens were tested at 45%, 80%, and 85% of SMYS. The 85% SMYS stress level is regarded as an aggressive performance test for metal that is in direct contact with a 100% H₂S saturated environment. Pressure was monitored continuously throughout the test and the time to failure recorded. Figure 5 shows a coupling placed in the pressurized test apparatus.

FIGURE 5: FULL SIZE COUPLING BLANK PLACED IN PRESSURIZED TEST APPARATUS.

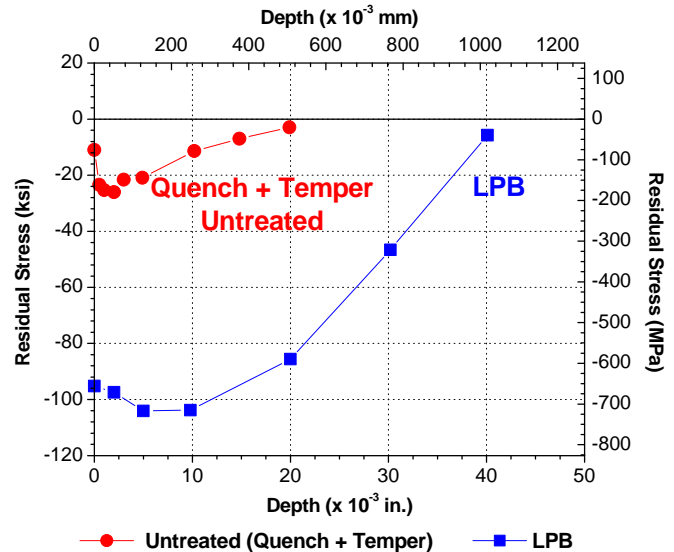
The residual stress distributions, measured as functions of depth, are presented graphically in Figure 6. Compressive stresses are shown as negative values, tensile as positive, in units of ksi (10³ psi) and MPa (10⁶ N/m²). LPB produces max compression of -105 ksi (~ -724 MPa), and gradually decreases to zero at a depth greater than 0.040 in. (~1 mm).

FIGURE 6: RESIDUAL STRESS PROFILES

- LPB imparted a deep compressive layer of stable residual compression over 2X deeper and 10X greater in magnitude than the untreated couplings.
- LPB processing increased HCF life by 50X and fatigue strength by 2X over the untreated condition with 0.020 in. (0.51 mm) deep damage.

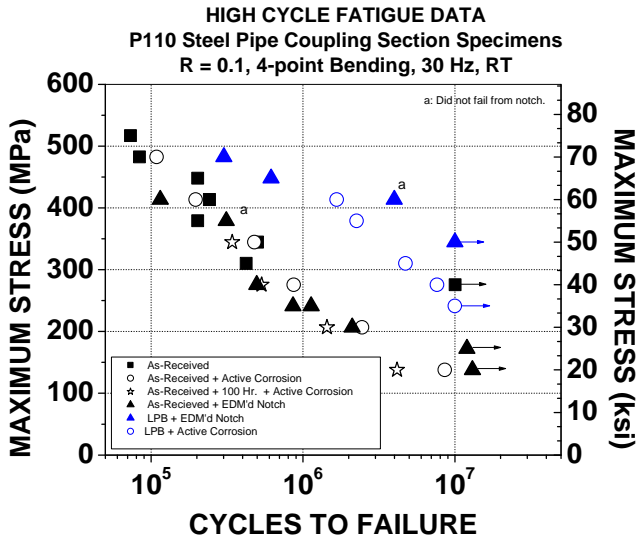
Figure 7 shows stress vs. life (S-N) curves for the tested samples. The as-machined samples with a 0.020 in. (0.51 mm) deep EDM notch have a fatigue strength at 10⁷ cycles of approximately 25 ksi (~170 MPa). LPB samples containing a 0.020 in. (0.51 mm) deep notch have a fatigue strength of 50 ksi (~345 MPa) at 10⁷ cycles, nominally 2X the fatigue strength of the untreated samples with an increase in life of greater than a factor of 50X.

When subjected to corrosion damage the untreated samples have a fatigue strength of less than 20 ksi (~138 MPa). LPB samples subjected to active corrosion have a fatigue strength of 35 ksi (~241 MPa) approximately 1.75X greater than the untreated samples. Furthermore, LPB treated samples exhibit an increase in fatigue life of nominally an order of magnitude over the untreated samples.

FIGURE 7: HIGH CYCLE FATIGUE RESULTS FOR API-P110 STEEL SPECIMENS

- When exposed to active corrosion LPB treated samples revealed a nominal 10X improvement in life and a 1.75X improvement in strength over untreated samples.

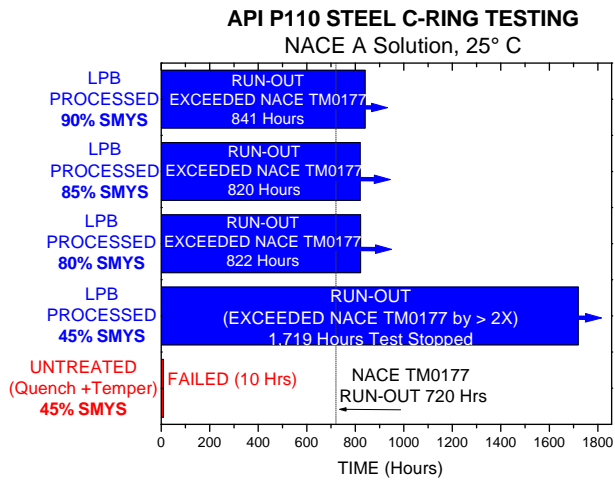
SSC results are presented graphically in Figures 10 and 11. The un-treated C-ring specimen failed in 10 hours at a stress of 45% SMYS. The LPB processed specimens exceeded the run-out life of 720 hours at 45%, 80%, 85% and 90% of SMYS exceeding typical hold-time requirements for testing in a sour service environment. The full sized pressurized coupling test results are very similar with the untreated coupling failing in 37.5 hours. The LPB processed specimens exceeded 720 hours at 45%, 80% and 85% SMYS stress levels while surpassing typical hold-time requirements for sour service testing. The second full sized LPB coupling blank ran for a total of 1454.75 hours in solution before testing was terminated and the specimen was removed from solution for dye inspection, which revealed no cracking. These test results demonstrate the dramatic improvement achieved by the LPB treatment..

FIGURE 10: SSC C-RING TESTING RESULTS

- The LPB processed C-ring tests exceeded NACE TM0177 time requirements at stress levels of 45%, 80%, 85%, and 90% of SMYS. The untreated C-ring failed in 10 hrs at a stress of 45% SMYS.

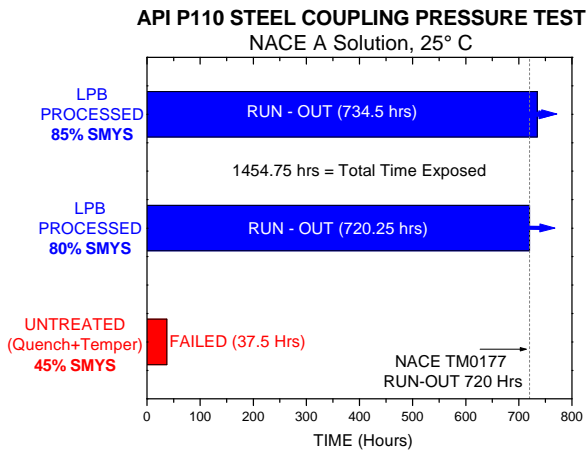
FIGURE 11: SSC FULL SIZED COUPLING BLANK TEST RESULTS

- LPB completely mitigated SSC failure. The LPB treated full sized coupling tests exceeded the NACE TM0177 720 hour NACE exposure time requirement at 45%, 80%, and 85% of the SMYS of 110 ksi (759 MPa) where the untreated coupling failed in 33 hrs. at a stress of 45% SMYS.
