MITIGATION OF SCC AND CORROSION FATIGUE FAILURES IN 300M LANDING GEAR STEEL USING MECHANICAL SUPPRESSION

Paul S. Prevéy and N. Jayaraman Lambda Research 5521, Fair Lane, Cincinnati, OH 45227 – 3401

Proceedings of the 6th Aircraft Corrosion Workshop August 24-27, 2004, Solomons, MD

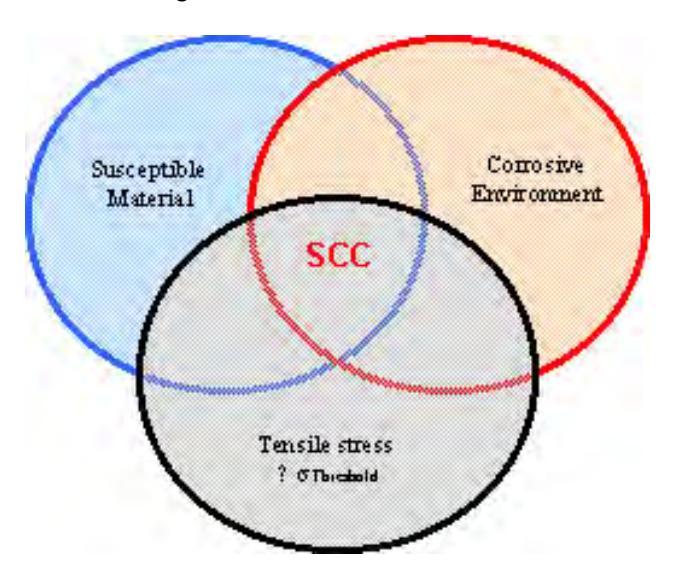
FIGURE 1 - SCC susceptibility diagram illustrating the need for the combination of a susceptible material, corrosive environment and threshold tensile stress to cause SCC.

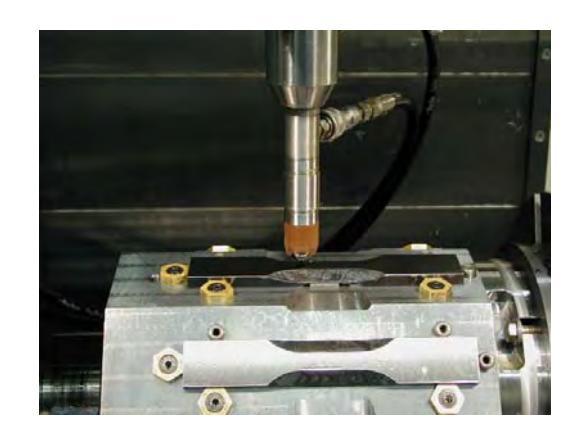
FIGURE 2 - A set of 8 thick section specimens being LPB processed in a 4-axis CNC milling machine.

LPB process parameters were developed by Surface Enhancement Technologies, LLC. (SET) for thick sections of 300M steel using proprietary methods. The CNC control code was modified to allow positioning of the LPB tool in a series of passes along the gage section while controlling the burnishing pressure to develop the desired magnitude of compressive stress with relatively low cold working. Figure 2 shows a thick section fatigue specimen in the process of being LPB processed in the four-axis manipulator on the CNC milling machine.

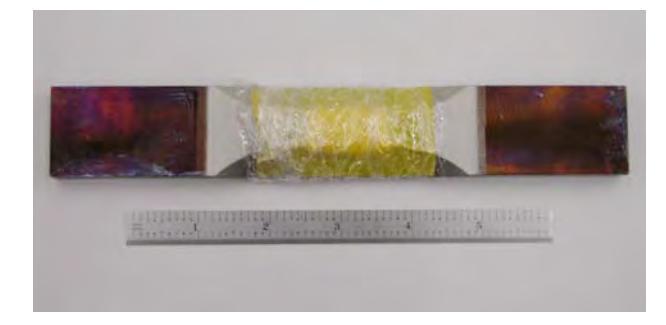
FIGURE 3 - A thick section specimen with salt solution soaked tissue wrapped around the gage section.

Corrosion fatigue testing was performed in a medium of neutral 3.5% NaCl salt solution made using de-ionized water. Filter papers were soaked with the solution, wrapped around the gage section of the fatigue test specimen, and sealed with a plastic film to avoid evaporation. Figure 3 shows a specimen with the acid salt soaked filter paper sealed around the gauge section. To simulate FOD, a semielliptical surface notch of depth of $a_0=0.020$ in. (0.5 mm) and surface length of $2c_0=0.060$ in. (1.5 mm) was introduced in selected groups of specimens by electrical discharge machining (EDM), as shown in Figure 4. Figure 5 shows the specimen mounted in the four-point bend fixture assembled for fatigue testing in a Sonntag SF-1U HCF machine. The following list describes the test conditions used in this study:

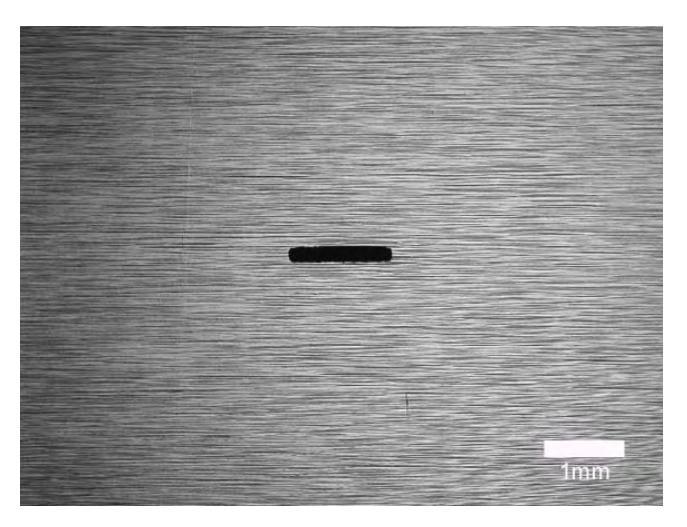
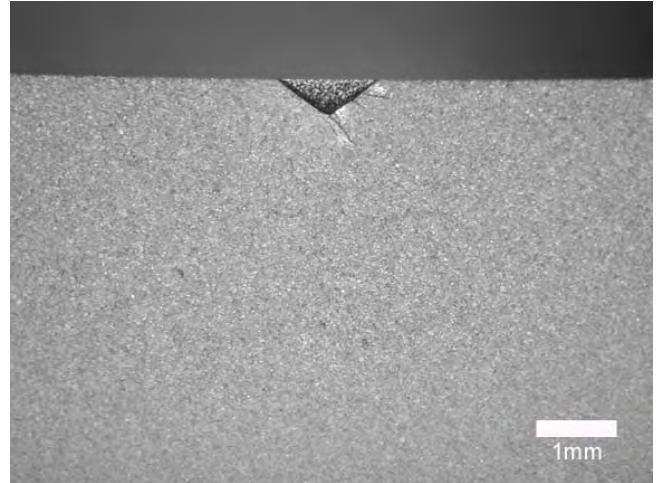
FIGURE 4a.

FIGURE 4 - EDM notch to simulate FOD. (a) Top view, and (b) Cross-section of a 0.020 in. deep notch.

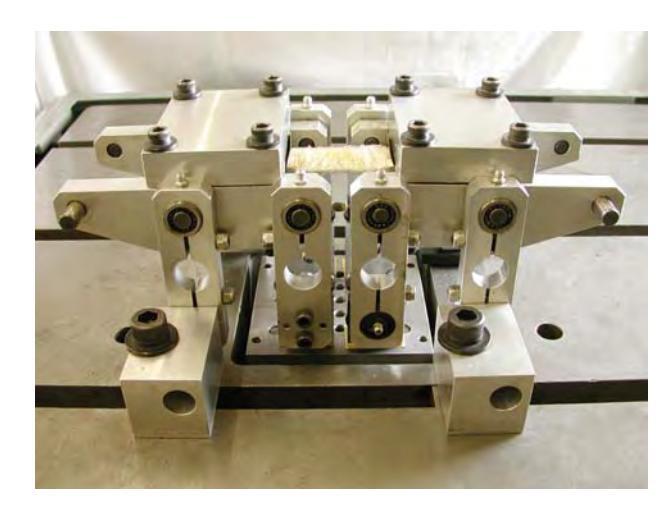
FIGURE 5 - Fatigue test set up.

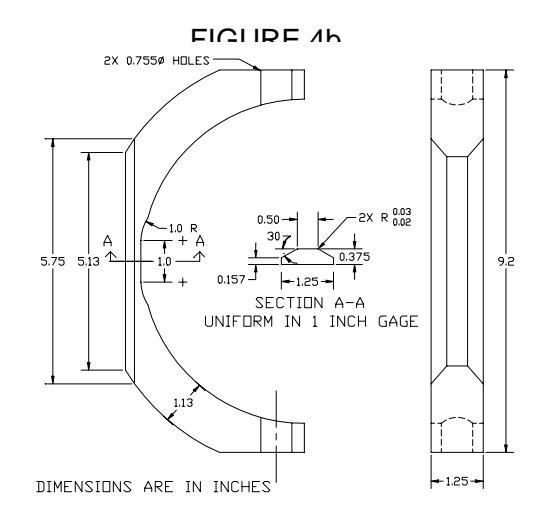
FIGURE 6 - C-ring specimen for SCC tests.

SCC tests were performed on C-ring specimens (Figure 6) machined out of an actual landing gear made of 300M steel. The gage region of the C-ring specimen had a cross section similar to the fatigue specimens shown in Figure 2. This design made it possible to investigate the effect of surface treatments like LPB for the SCC tests. Typically, when the specimen is loaded with a bolt through the 3/4 in. (19 mm) hole, the outer surface of the trapezoid is in tension, and the tensile stress is uniform over the 1 in. long parallel gage section of this specimen. From the knowledge of the applied forces on the (instrumented) bolt, the bending moment and the corresponding tensile stress on the outer surface can be calculated. Three sets of specimens (both in untreated condition and LPB treated) were SCC tested at 150, 165 and 180 ksi. The SCC test consisted of alternate immersion of the loaded specimen in a neutral 3.5% NaCl solution made with deionized water (10 min. in solution and 50 min. in air at room temperature). The load was monitored as a function of time, and the time to failure was noted.

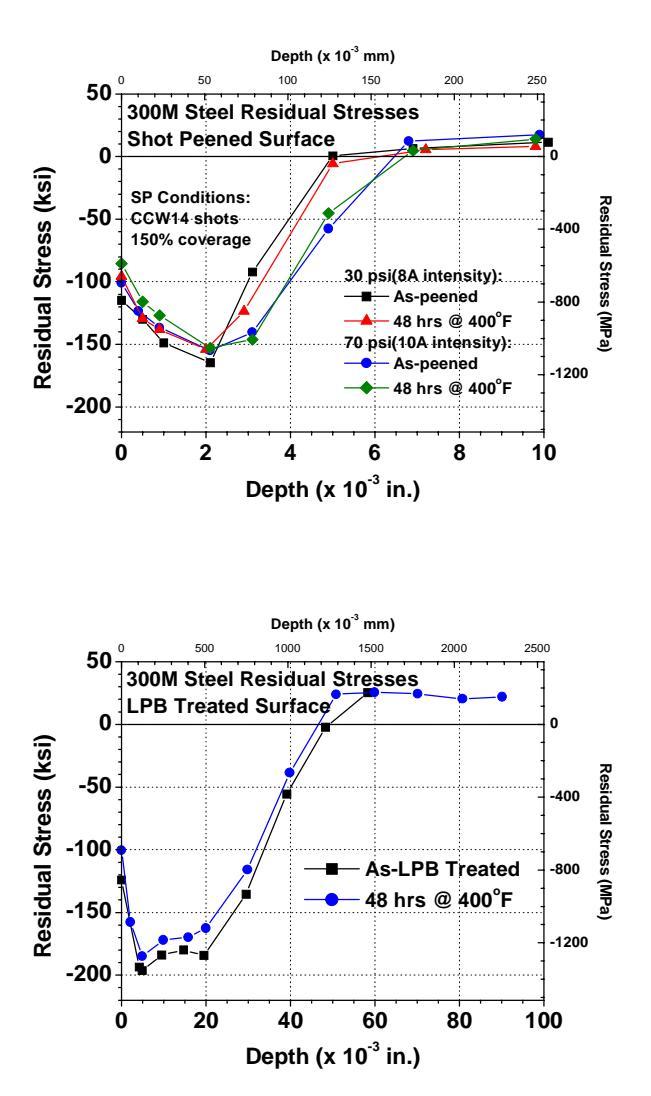
FIGURE 7 - Residual stress distribution for SP and LPB processed specimens. Thermal exposure at 400°F showed no significant effect on residual stresses.

The residual stress distributions measured as functions of depth are presented graphically in Figure 7. Compressive stresses are shown as negative values, tensile as positive, in units of ksi (10³ psi) and MPa (10⁶ N/m²). SP treatment at 8A intensity shows surface compression in the range of -100 to -115 ksi (-690 to -790 MPa), which becomes more compressive to about -150 ksi (-1035 MPa) at a depth of about 0.002 in. (0.05 mm), and rapidly relaxes to nearly zero at a depth of about 0.005 in. (0.125 mm). The 10A intensity of peening introduced a little deeper compression to a depth of 0.007 in. (0.18 mm). The residual stresses from both the SP treatments did not relax significantly after thermal exposure to 400°F for 48 hours. LPB treatment produces surface compression of -100 MPa), which becomes ksi (-690 more compressive to about -180 ksi (-1240 MPa) at depths of 0.005 to 0.020 in. (0.125 to 0.5 mm) and gradually decreases to zero at a depth of about 0.050 in. (1.25 mm). Again, thermal exposure to 400°F for 48 hours did not result in significant relaxation of residual stresses.

Figure 11 shows a summary of HCF and corrosion fatigue test results. Here, it is evident that for both baseline and SP materials, a 0.020 in. (0.25 mm) deep EDM notch greatly decreases the HCF and corrosion fatigue strength to a value between 30 and 10 ksi (200 and 70 MPa). In contrast, the LPB treated specimens withstood the same EDM notch with a fatigue strength of 145 ksi (1000 MPa). Again, the HCF and corrosion fatigue performance for the LPB treated specimens are consistent with the residual stress distributions seen in Figure 7.

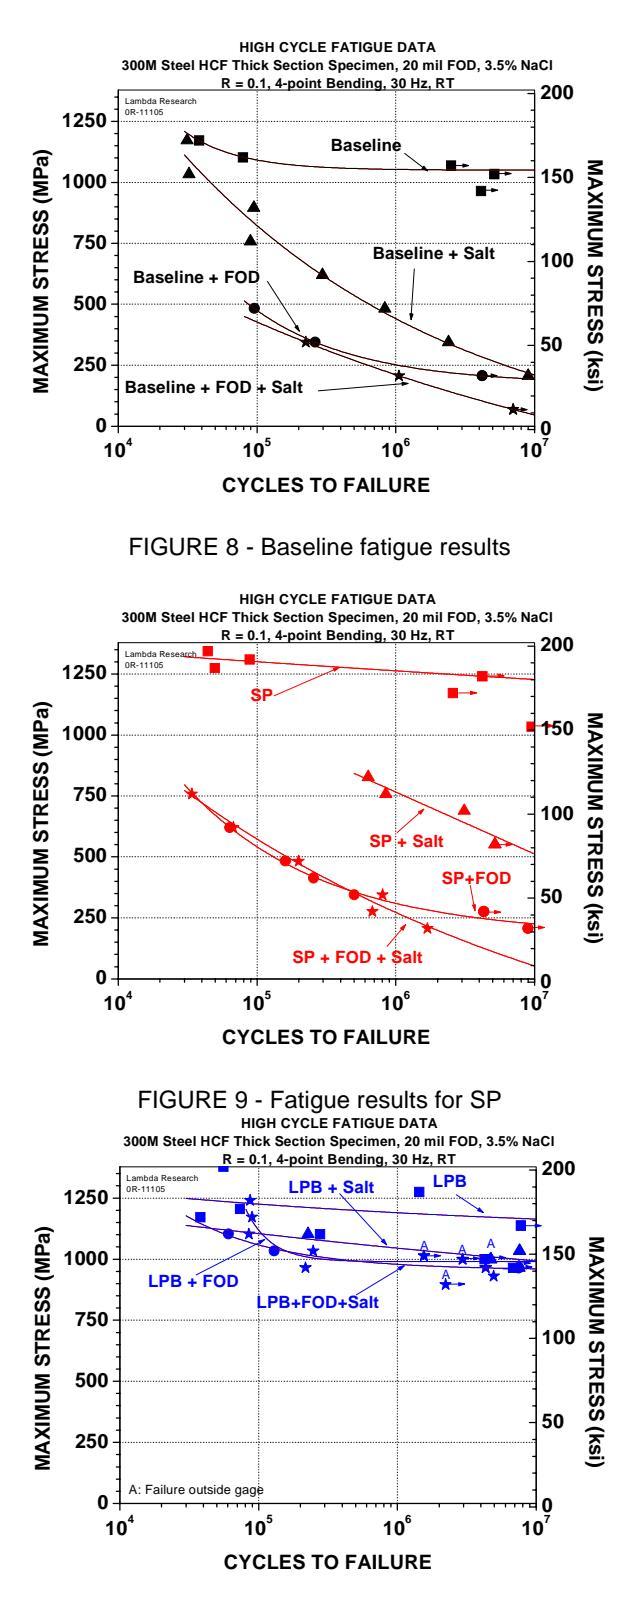
FIGURE 10 - Fatigue results for LPB

Figures 8-11 show the HCF and corrosion fatigue performance of 300M steel in the form of S-N curves. In Figure 8, the baseline material performance with and without the EDM notch

and exposure to the corrosive environment is presented. The unnotched baseline condition shows a fatigue strength (endurance limit at about 10⁷ cycles) S_{max} of about 150 ksi (1035 MPa). In the presence of a neutral (3.5% NaCl) salt solution environment, the corrosion fatigue strength for baseline drops dramatically to about 30 ksi (205 MPa). In fact, the baseline material, which exhibited a strong endurance limit behavior, showed a total loss of endurance strength in the presence of salt solution. Introduction of a semi-elliptical EDM notch of nominal size $a_0=0.020$ in. (0.5 mm) and co=0.030 in. (0.75 mm) drastically decreases the fatigue strength to about 30 ksi (~140 MPa) for air and to less than 10 ksi (70 MPa) for corrosion environment. Power law lines were fitted to the data in Figure 8, and represent the average behavior of the material in its baseline condition.

Figure 9 shows the HCF and corrosion fatigue performance of both unnotched and notched SP treated specimens. Benefits of surface compression from the SP treatment are clearly seen by way of improved HCF performance of the unnotched specimens. Corrosion fatigue strength in the presence of neutral salt environment drops to about 75 ksi (515 MPa). It is interesting to note that this drop of fatigue strength by a factor of 2 is not as severe as the factor of 5 drop seen in the baseline material. The small benefits of shallow compression from shot peening are evident in these results. However, the introduction of a 0.020 in. (0.5 mm) deep notch reduces the performance similar to the notched baseline condition both in air and in the presence of the neutral salt environment. This is not surprising since the corresponding residual stress profile (shown in Figure 7) indicates a depth of compression much shallower than the depth of the EDM notch.

Figure 10 shows the HCF and corrosion fatigue behavior of LPB treated specimens. The unnotched specimen shows superior HCF performance with a fatigue strength of 175 ksi (1200 MPa). Figure 10 also shows that fatigue data from all of the other test conditions with LPB treatment. Notched HCF and both notched and unnotched corrosion fatigue test results may be grouped into one set of data at a slightly lower fatigue strength of 145 ksi (1000 MPa). Three conclusions may be reached from this data. First, the LPB process has effectively mitigated corrosion fatigue. Second, the HCF and corrosion fatigue performance of this group is statistically similar to the unnotched baseline material. Third, the endurance limit behavior that was absent in both baseline and SP treatment when tested in the neutral salt solution environment is restored with the LPB treatment.

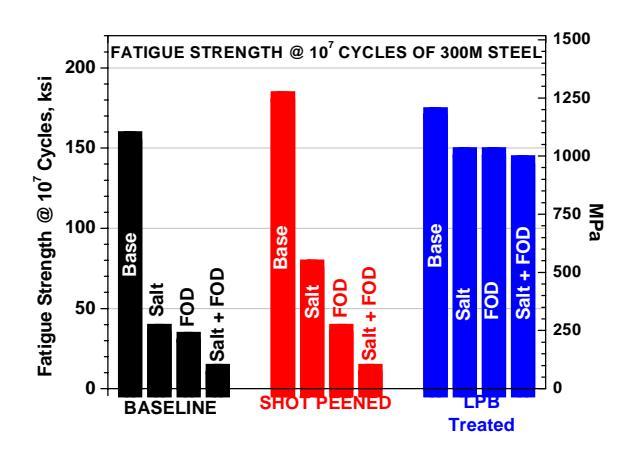
FIGURE 11 - Summary of fatigue results

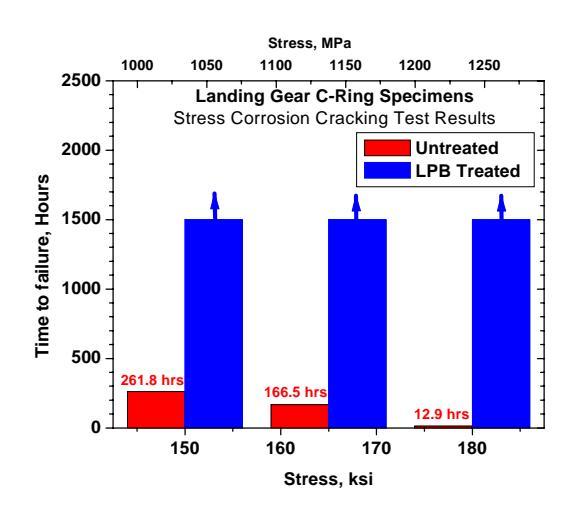
FIGURE 12 - SCC test results.

In Figure 12 the SCC test results show that the untreated baseline material had SCC time to failure of 261.8 hrs at 150 ksi (1034 MPa), 166.5 hrs at 165 ksi (1138 MPa) and 12.9 hrs at 180 ksi (1241 MPa), respectively. The LPB treated specimens did not fail even after 1500 hrs of exposure at all three stress levels. In fact, when the specimens were loaded to higher stress levels in the hope of getting them to crack by SCC, instead of cracking, the specimens were severely bent at higher loads. These results indicate the deep surface compressive stresses from LPB fully mitigated SCC.

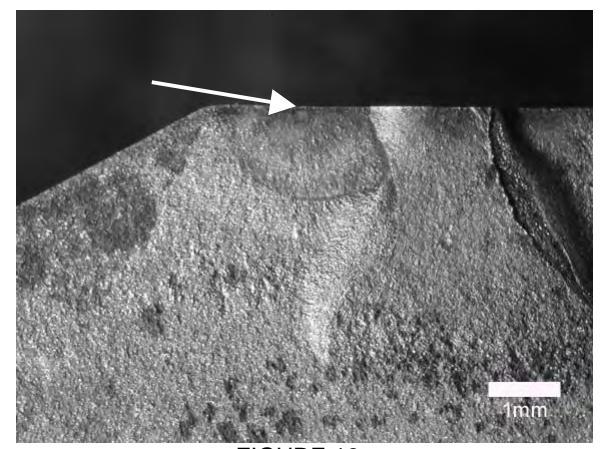
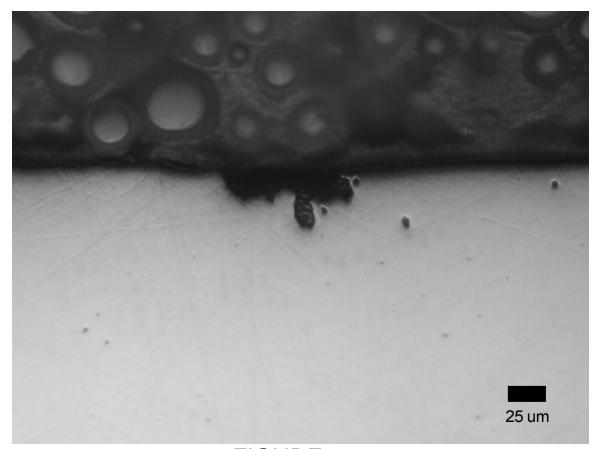
FIGURE 13 - (a) Fracture surface showing crack initiation (arrow) from a corrosion pit, (b) gage surface of the specimen showing a typical set of corrosion pits, and (c) cross-sectional view of a typical corrosion pit in a corrosion fatigue tested baseline specimen; S/N 97, Smax=50 ksi, Nf=2.4(10⁶) cycles (~24 hours)

Fractographic analyses presented here are limited to unnotched, corrosion fatigue tested specimens with baseline, SP and LPB conditions. Fractographic analyses of the notched and other HCF test conditions yielded results that are expected and consistent with the fatigue test results shown in Figures 8-11, therefore were not considered to be worthy of inclusion. Figures 13, 14 and 15 show the mechanisms of crack initiation and crack growth corrosion fatique conditions. under of unnotched specimens. Figure 13a shows the fracture surface of a baseline specimen with a single crack initiation site near the corner of the trapezoidal cross-section. Figures 13b and c show the role of corrosion pits on the crack

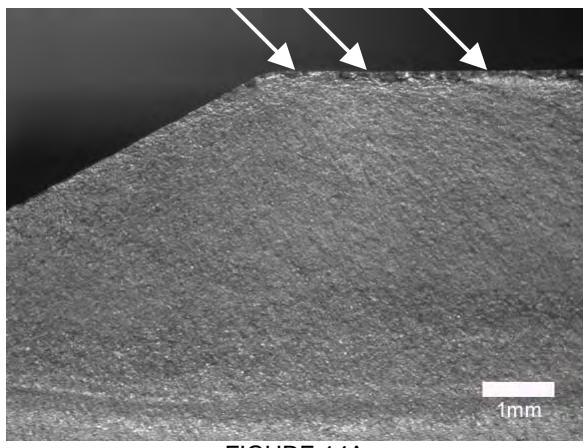
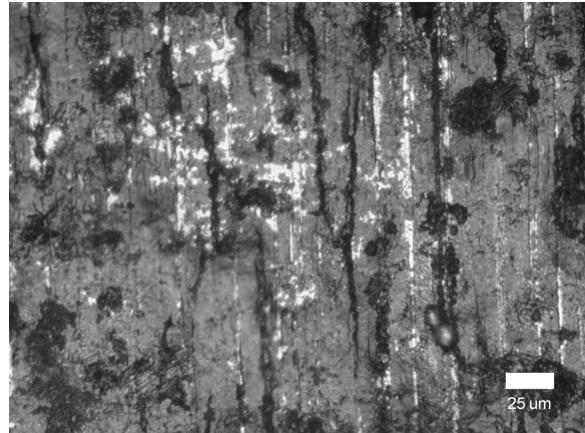
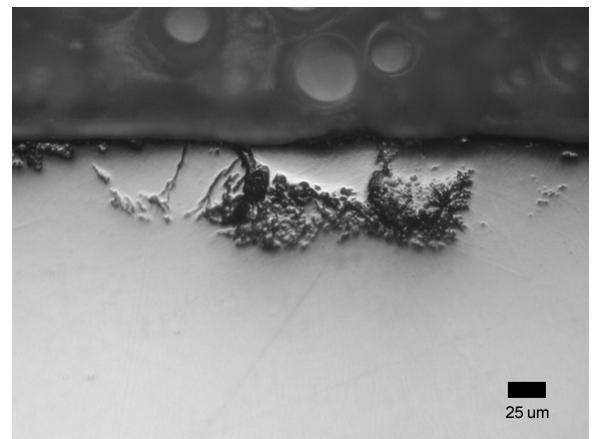
FIGURE 14 - (a) Fracture surface showing multiple crack initiation (arrows) sites, (b) gage surface showing a set of typical corrosion pits, and (c) cross-sectional view of a typical corrosion pit in a corrosion fatigue tested SP specimen; S/N 94, Smax=100 ksi, Nf=3.1(10⁶) cycles (~30 hours)

initiation process. Similarly Figures 14a, b and c, and Figures 15a, b, c and d show the optical fractographs, the gage of surface with corrosion pits, and the cross-sectional view of a corrosion pit in an unnotched SP and LPB specimen. In all cases, severe pitting of the gage surface is evident, and the cross-sectional views indicate a gradual increase in the depth of corrosion pitting damage with increased time of testing. In both baseline and SP specimens, the corrosion pits resulted in early crack initiation at low stresses, leading to final failure. In contrast, for LPB specimens, despite the higher stress levels and deeper corrosion pitting damage, the corrosion fatigue performance is minimally affected. This is seen in Figures 15a and b, where subsurface crack initiation is evident despite the presence of deep corrosion pits similar to the one seen in the cross-sectional view in Figure 15d.

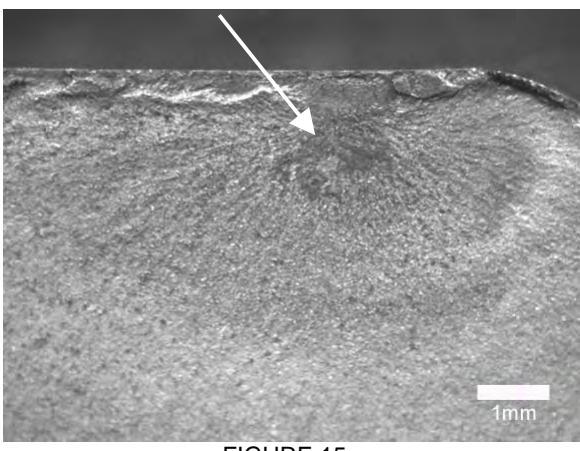
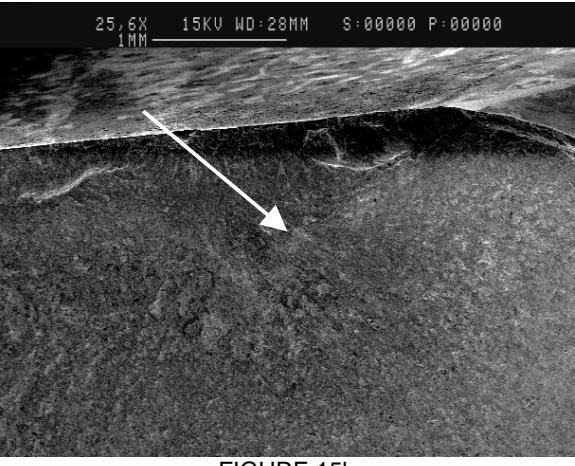
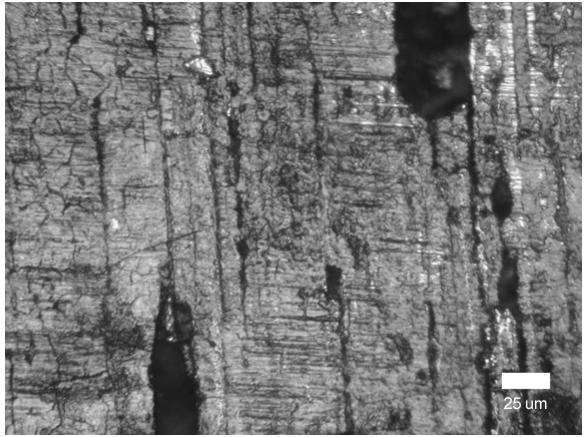
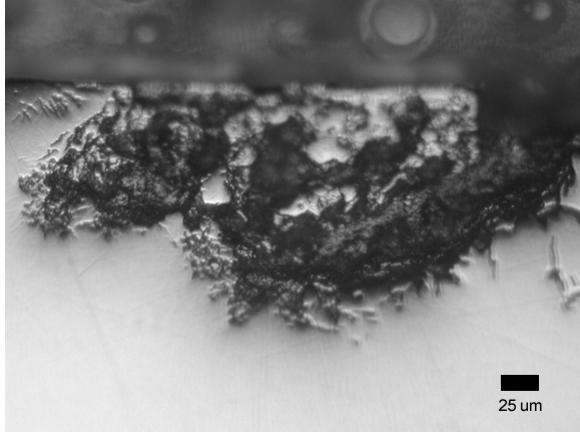
FIGURE 15 - (a) Optical fractograph showing sub surface crack initiation (arrow) site, (b) SEM fractograph showing the same region, (c) gage surface corrosion pits, and (c) cross-sectional view of a typical corrosion pit in a corrosion fatigue tested LPB specimen; S/N 11, Smax=150 ksi, Nf=7.1(10⁶) cycles (~70 hours)
