Improving Corrosion Fatigue Performance of AA2219 Friction Stir Welds with Low Plasticity Burnishing

P. Prevéy
D. Hornbach
P. Mason
Lambda Research

Abstract

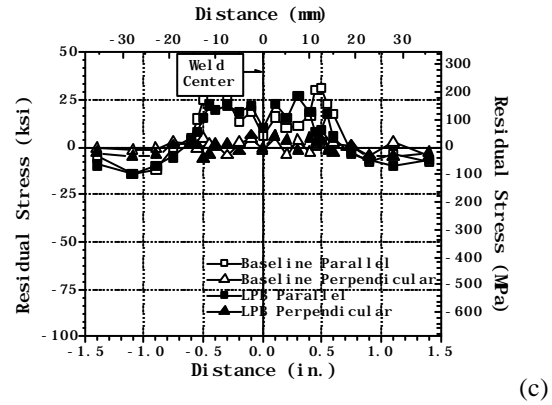
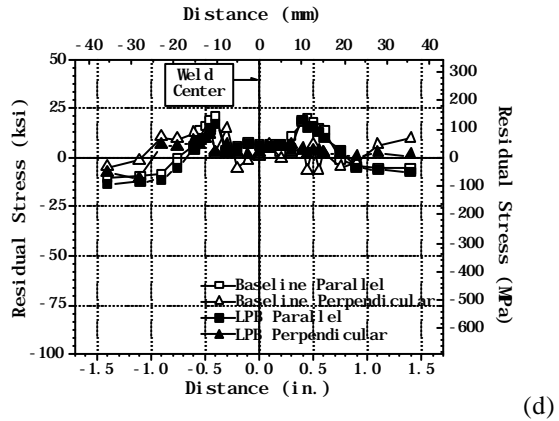
Figure 4: Residual stress measurements in FSW 2219 T8751 aluminum with and without low plasticity burnishing, (a) weld surface, (b) 1/4 thickness, (c) 1/2 thickness, (d) 3/4 thickness, and (e) weld root surface.

The residual stress distributions measured as functions of depth and distance from the weld centerline are presented in Figures 4a-4e. Each plot presents residual stresses parallel and perpendicular to the weld line for a given depth through the thickness of the plate in 1/4 thickness increments. On the weld surface and root surface, residual stresses were also measured in the 45° direction. Compressive stresses are shown as negative values and tensile as positive.

At the weld surface, the as-welded samples are in tension in the parallel direction and compression in the perpendicular direction. Following LPB, the residual stress is compressive in all directions, ranging from -180 to -500 MPa at the weld surface.

Residual stresses vary as a function of distance from the weld centerline reaching minimums in the regions that correspond to the HAZ's on both the advancing and retreating sides. This is likely due to the LPB procedure. In this study, no attempt was made to adjust the burnishing load to the yield stress of the 2219 Al. Thus, in the softer HAZ's, the response to the LPB would be different than that in the higher yield stress weld zone and parent metal.

At 1/4, 1/2, and 3/4 thickness, the as welded and LPB samples have similar residual stress patterns, Figs. 4b-4d. The influence of the LPB was limited to a depth of less than 1/4 thickness in order to minimize distortion. The results for both samples show an increase in tensile residual stresses in the parallel direction at mid-thickness. Tensile stresses are highest near the weld edges and approach +240 MPa. These are much higher values than reported previously where measurements were taken only near the crown and not at the root.¹⁶

Figure 4e illustrates residual stresses on the weld root surface. For the as-welded sample within the weld zone, residual stresses are compressive and relatively low at approximately -100MPa in the parallel, 45°, and perpendicular directions. Following LPB, these stresses become more compressive ranging from -20 to -250MPa. Although only the top surface was treated by LPB, the bottom surface experiences compression due to plate bending.

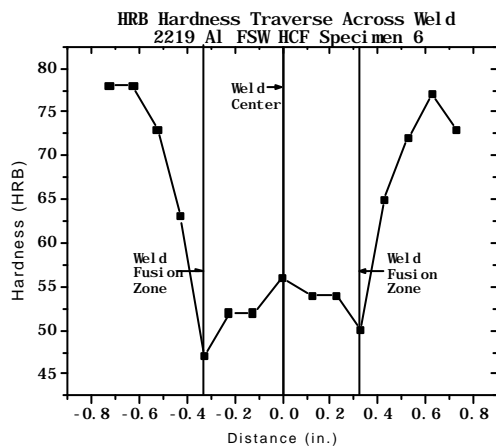
Figure 5: Surface hardness traverse on Milled fatigue specimen showing softened weld material.

Surface hardness measurements, made on an as welded + milled specimen are shown in Figure 5. The measurements are shown on a Rockwell B scale as a function of distance from the weld center. The results indicate relatively soft material in the weld as compared to the parent material. The softest material is located near the edges of the weld.

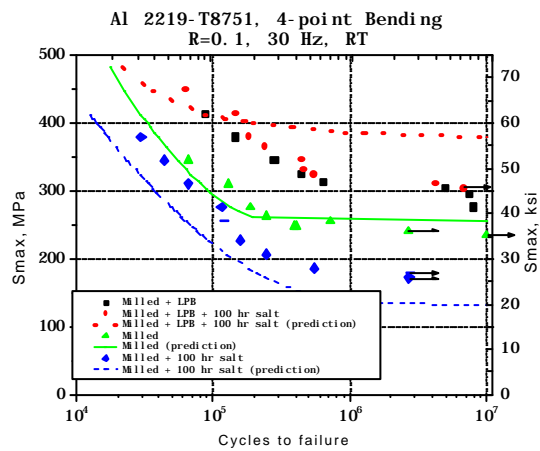
Figure 6 - Fatigue and corrosion/fatigue test results for friction stir welded 2219-T8751 aluminum with and without low plasticity burnishing.

High cycle fatigue results are presented in Figure 6 for the different test conditions. For FSW material, with the flash and circular tool pattern removed by milling, the endurance limit was nominally 230MPa. The endurance limit for the Milled specimens was decreased by nominally 25% after the 100 hr salt exposure. LPB of the Milled samples increased the endurance limit to 300MPa. The 100 hr. salt exposure had little influence on the fatigue strength of the LPB specimen.

Figure 6 shows a comparison of test results of test specimens and SN curves generated from the life prediction analysis. Generally for the as-milled specimens and milled specimens exposed to 100 hrs of salt, the predicted S-N curves gave reasonable validation of test results. The fact that the as-milled prediction was a little on the conservative side indicates that the starting crack/notch conditions are much less severe than what was assumed in the model, while for the 100 hrs salt exposed condition for milled specimens

The results for specimens with surfaces treated with the LPB process were quite different; both in the LPB processed conditions and LPB + 100 hrs salt exposure conditions, the predictions were consistently higher than the test results. In fact, the predictions for the LPB processed condition were so high that those are not even presented in this figure and the ones for LPB + 100 hrs salt exposure is clearly higher than the test results. Another clear observation from Figure 6 is that while the as-milled and milled + 100 hrs salt exposure conditions showed significant differences in fatigue life performance (both in fatigue life at the same stress level and in the corresponding fatigue strengths), the results for the LPB processed and LPB + 100 hrs of salt exposure conditions are almost indistinguishable. Coincidentally, most test specimens under these test conditions showed sub-surface crack initiation, thus making the effect of corrosion irrelevant in the analysis. A more accurate life-prediction methodology incorporating sub-surface cracking mechanisms is needed to fully and more accurately predict fatigue life. This is currently being completed in an in-house research program at Lambda Research.

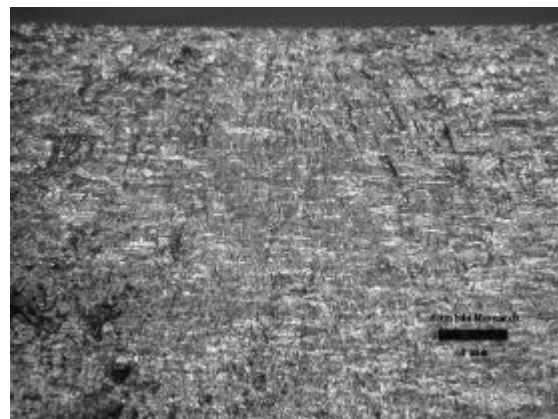
Figure 7: Fracture face showing typical surface failure for milled specimen.

Fatigue initiation sites for the milled specimens were typically at the surface within the gage region. An

example of a surface initiation is shown in the photo in Figure 7. Specimens that were cycled at higher maximum stresses had multiple initiations, but were also within the gage. Almost all the initiation sites were outside of the weld material. LPB moved the fatigue initiation site from the surface of the gage section to the corners as shown in Figure 8. At low stresses, crack initiation was located subsurface at the corners. An example of a subsurface initiation is shown in Figure 9. Subsurface initiations, originating below the highly compressive surface, do not effectively demonstrate the full effect of LPB processing on fatigue performance. Presumably, an even higher applied stress would have been required to initiate failure from the surface. However, the occurrence of failures below the LPB compressive layer reveals the substantial fatigue enhancement benefits of LPB.
